Western Star  
Service Bulletin

**Description of revisions:** *This bulletin replaces the version dated October 2015. 5700 models have been removed from the affected vehicles list, and a cutoff date is added for the door stop bracket installation in step 4.*

## General Information

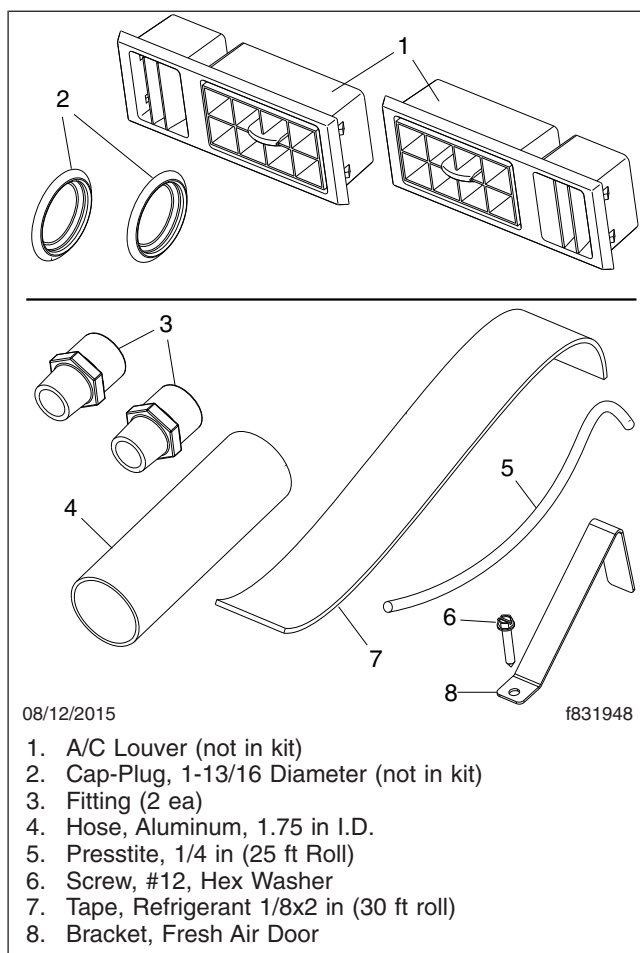
**Fig. 1, Side Window Defrost Retrofit Parts**

This procedure improves the side window defrost function and overall A/C performance on Western Star 4700, 4800, 4900, 6900 models. In extreme cold conditions, the side windows may ice up and limit visibility. A retrofit kit (WWS RD-3-19025-0) is available to remedy the side window issue. See [Fig. 1](#) for installation parts. Installation of the new louvers directs air flow to the side windows. Installing the fresh-air door-stop bracket, and sealing leaks in the A/C ducting, significantly improves air flow in heater/defrost and cooling modes, providing noticeable improvement in overall system performance.

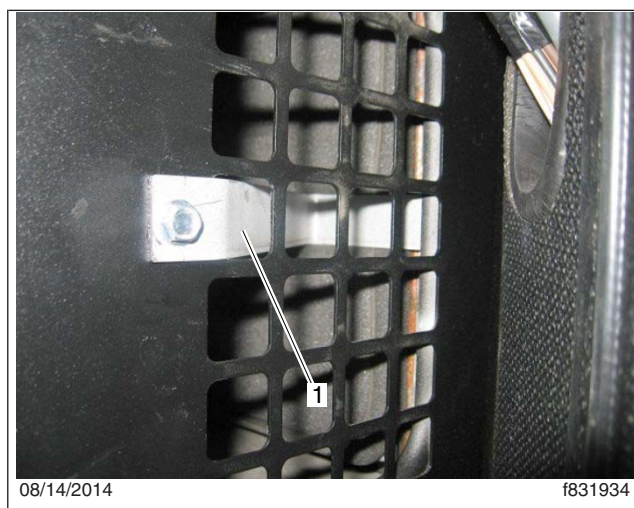
**Fig. 5, Fresh-Air Door-Stop Bracket Installation**

**NOTE:** All vehicles manufactured after October 1, 2015 have the door stop bracket factory installed.

4. If not already installed, install the fresh-air door-stop bracket.
  - 4.1 Remove the trim panel.
  - 4.2 Set the HVAC system to recirculation mode; this moves the door out of the way and allows access to the location for the bracket installation.
  - 4.3 Position the bracket and secure it with a self tapping screw as shown in [Fig. 5](#).

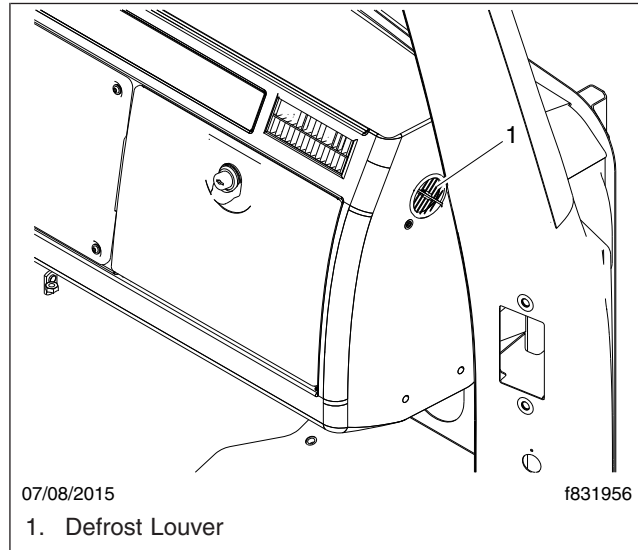
Fig. 6, Defrost Louver

NOTE: Some vehicles may have a round defrost louver outlet on the end of the dash facing the door panel. These outlets must be blocked.

5. If installed, remove the round defrost louvers at each end of the dash and install plugs in the holes. See [Fig. 6](#).
