MX13 Block Top Fit Liner

PACCAR POWERTRAIN

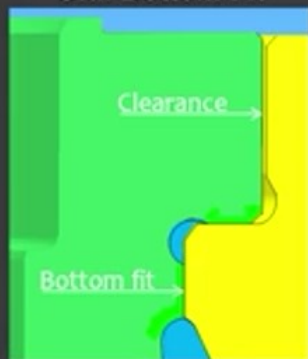
Old: Bottom Fit

The issue is fretting fatigue damage at the balconies. This problem is predominantly with NA17 HE500.
