SS 1033122 – Asymmetric Injection – GHG17 FE1 DD13/DD15 Engines (2016 trucks and newer)

Intermittent vibration felt while using light engine demand over the road (OTR)

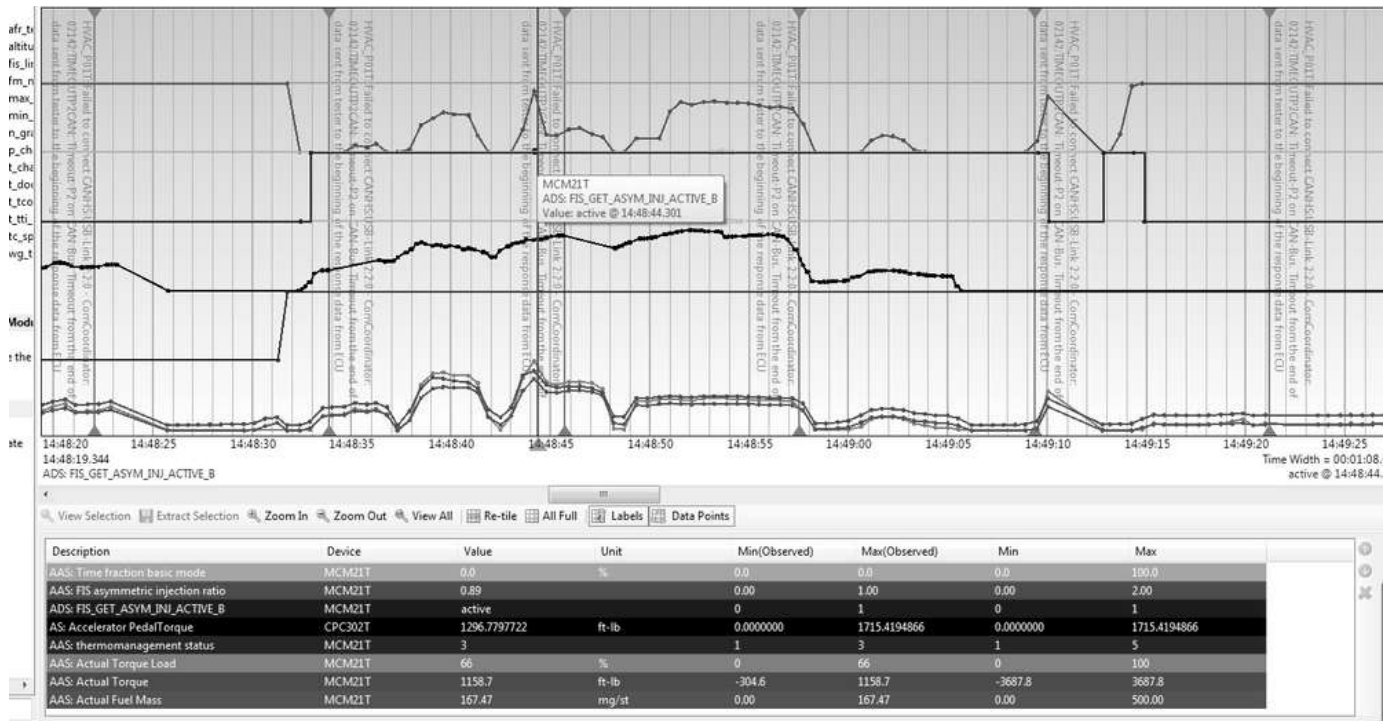
Utilizing Diagnostic Link (DLink), you can monitor these signals OTR to observe and verify AI is initiated and active:

When you look at my example of the chart in DLink, those are the majority of signals needed to confirm the amount of AI when this fueling strategy is happening. It will and DOES cause vibration complaints because the firing order of the 2nd bank is more heavily loaded than the front bank causing an uneven loping in power production to the PT.

So with this information you cannot find in any driver's manual, you can and will get more complaints of "driveline" vibration OTR that comes and goes. The best thing to do when confirming this is to take your EVA2 **and** your DLink in addition to monitor the thermal mode when the vibration is occurring and the ASYM_INJ_ACTIVE signal. Keep in mind, when the ASYM INJ RATIO is close to "1," the amount of injection difference is close to 0. When the ratio is "0," technically the front bank is no longer firing (or very little for that matter). You can also observe how the torque request changes in relationship to the AI ratio. Therefore, when monitoring your vibration complaint, observe how that changes with the ASYM INJ ratio and the magnitude of the vibration.
