SUBJECT: **Detroit<sup>™</sup> DT12<sup>™</sup> Split Rod Bushing Repair**

**Note:** This document supersedes Technical Service Letters 16 TS-22 and 17 TS-10.

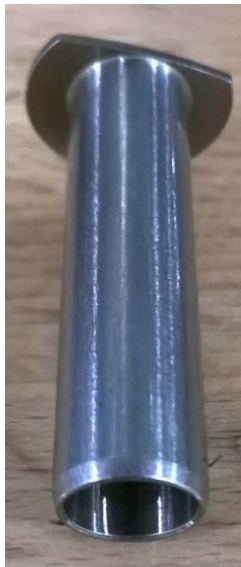
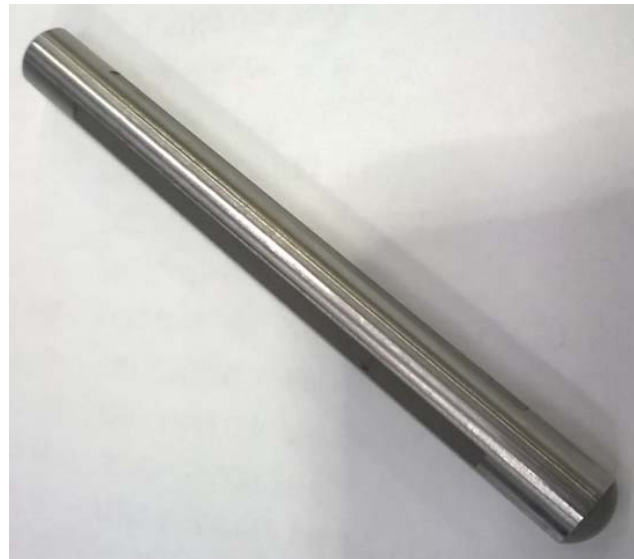
**Figure 1 – New Steel Bushing and Split Rod**

The steel split rod wears on the aluminum transmission housing, causing the split rod to stick. The Shift Controller cannot read the correct position of the split rod and will not shift into gear. To correct this, a hardened steel bushing and new design split rod with three flattened sides were implemented with transmissions built in August, 2016. For Detroit-built transmissions (transmission serial number beginning with 716), the change took place on August 9, 2016, with approximate transmission serial number 716310E0008107. For German-built transmissions (transmission serial number beginning with 715), the change took place on August 29, 2016, with approximate transmission serial number (last seven digits) 1806530. See Figure 1 for the new bushing and split rod.

The necessary parts to install the new bushing and split rod are contained in service kit P/N: A 960 268 23 74. The new kit is also shown in PartsPro in design group 342.

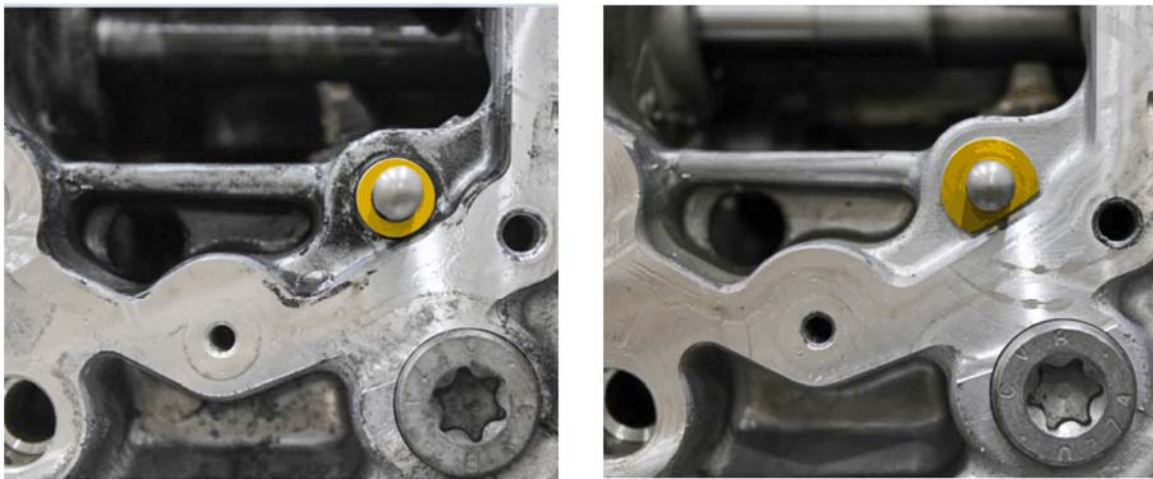
**Figure 2 – New Steel Bushing Installed**

See Figure 2 below for two different steel bushing designs that were implemented in production of new transmissions. Both styles below are new designs and do not need to be replaced in service.

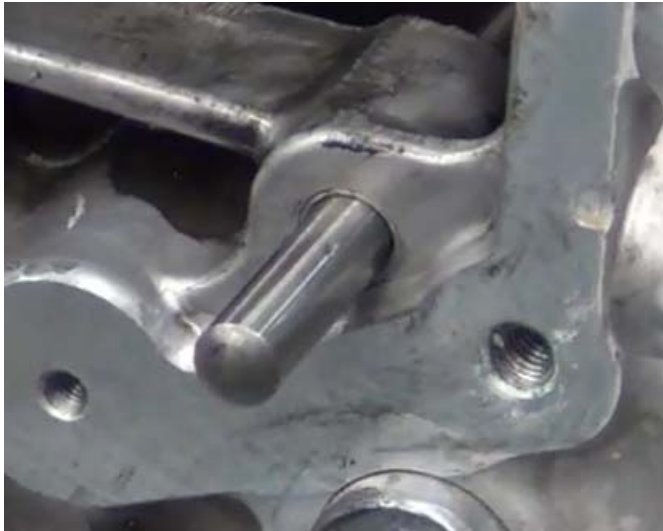
**Figure 3 – Old Style ream and bushing**

If you have the ream and bushing update, either of the new style steel bushings can be installed into the reamed bushing.
