Service Bulletin Number	Date
4383774	27-JAN-2015

## Service Bulletin

# ISX15 and QSX15 Piston and Cylinder Liner Change History, Identification and Compatibility

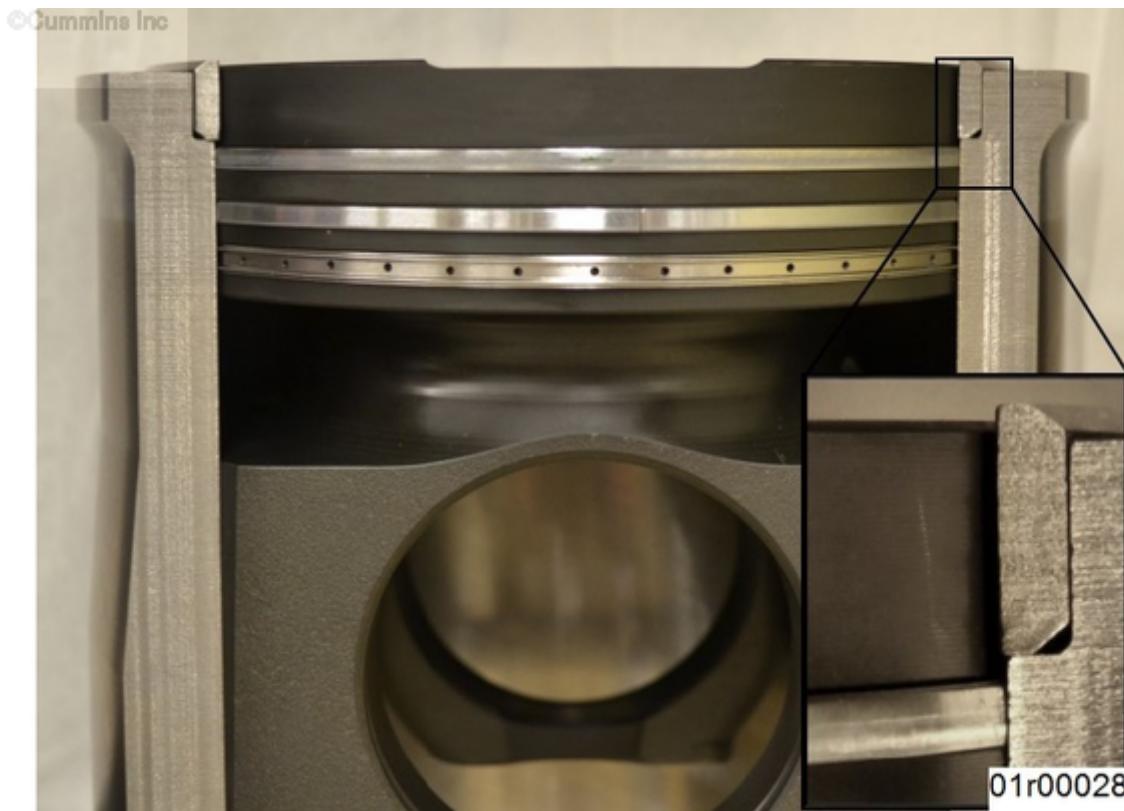
Anti-polishing ring cylinder liners can be identified by a removable carbon scraper ring known as the anti-polishing ring in the top of the cylinder liner. The cylinder liner has a counterbore machined into the top of the cylinder liner where the anti-polishing ring installs. The anti-polishing ring overhangs the liner bore allowing carbon to be scrapped from the piston top land which limits carbon thickness. Limiting the carbon thickness prevents carbon contact with the cylinder liner and prevents cylinder liner bore polish.

Anti-polishing ring cylinder liners will have two bands machined around the bottom outer diameter of the cylinder liner. This indicates that the cylinder liner is equipped with an anti-polishing ring and a brass shim. These bands are intended for cylinder liner identification when the cylinder liner is installed in an engine. The bands can be viewed or felt from the bottom of the engine when the lubricating oil pan is removed.

The anti-polishing ring is symmetrical so there is no top or bottom orientation.

Figure 1, Anti-polishing ring cylinder liner cross-section with low top ring piston and piston rings

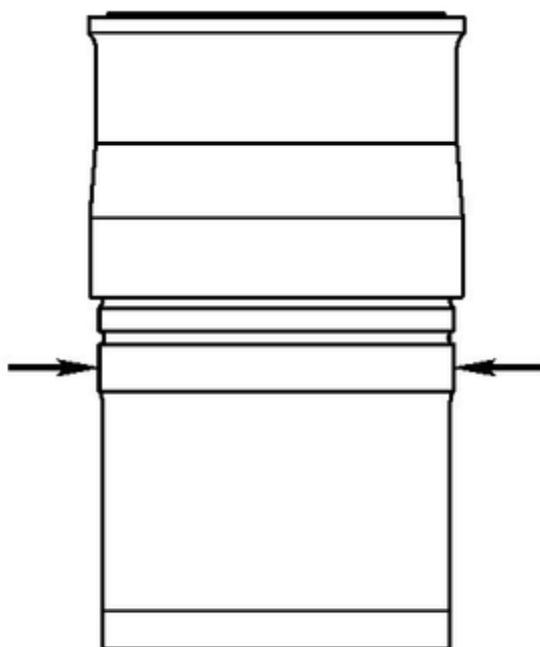
01r00029

Mid stop liners are available in 150 mm [ 5.906 in ] or 152 mm [5.984 in ] outer diameters. Measure the mid stop liner at the location shown in Figure 2 to identify the mid stop cylinder liner size.

Figure 2, Measurement location to identify the mid stop cylinder liner dimension

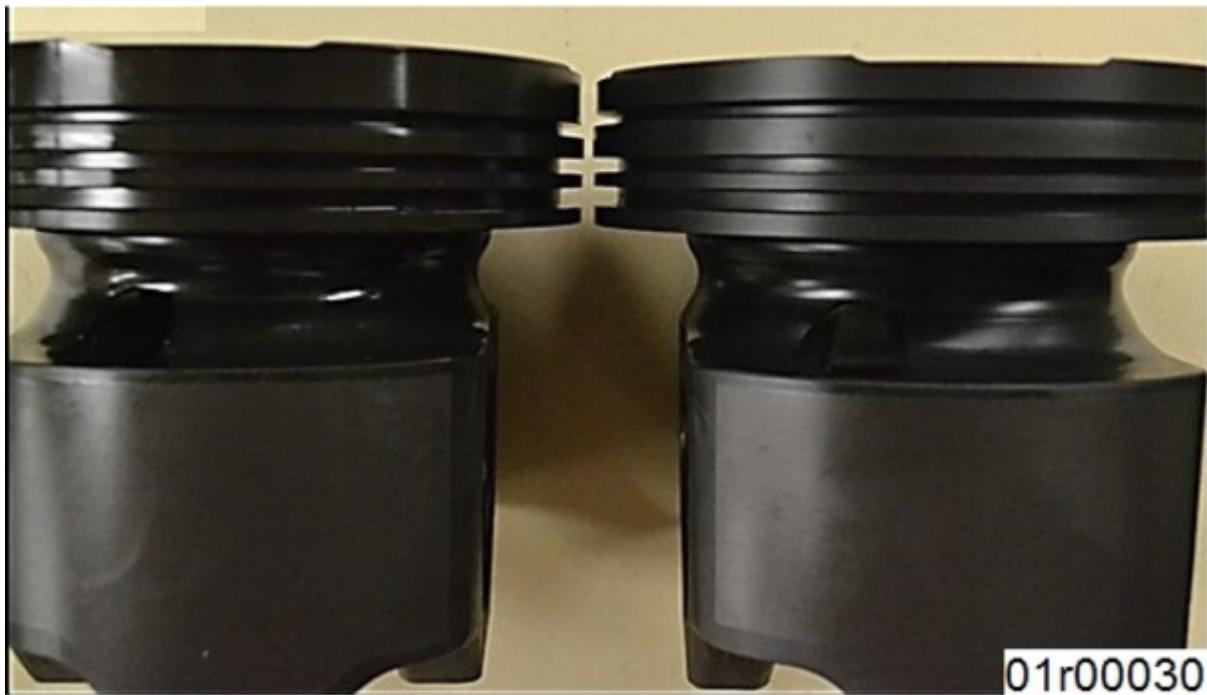
To identify a low top ring piston, set a piston on a flat surface with the combustion face down. Measure the distance from the combustion face to the start of the top ring groove. The low top ring piston will measure greater than 11 mm [ 0.433 in ]. A high top ring piston will measure approximately 8 mm [ 0.315 in ].

Figure 3, Low top ring piston on the left and a high top ring piston on the right

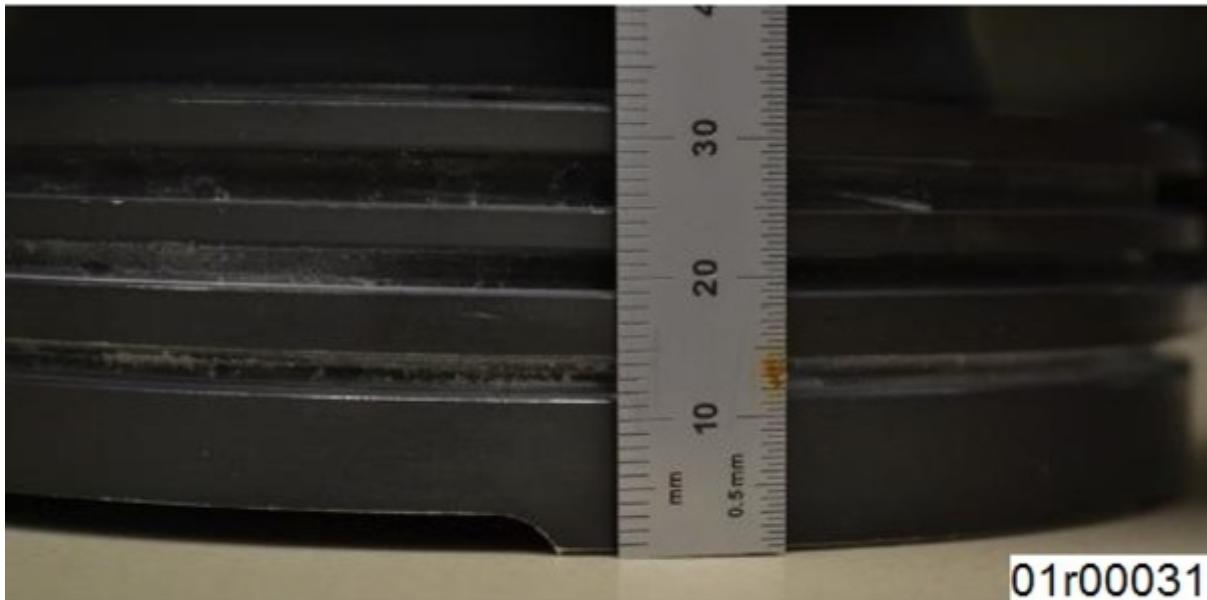
Figure 4, Low top ring piston

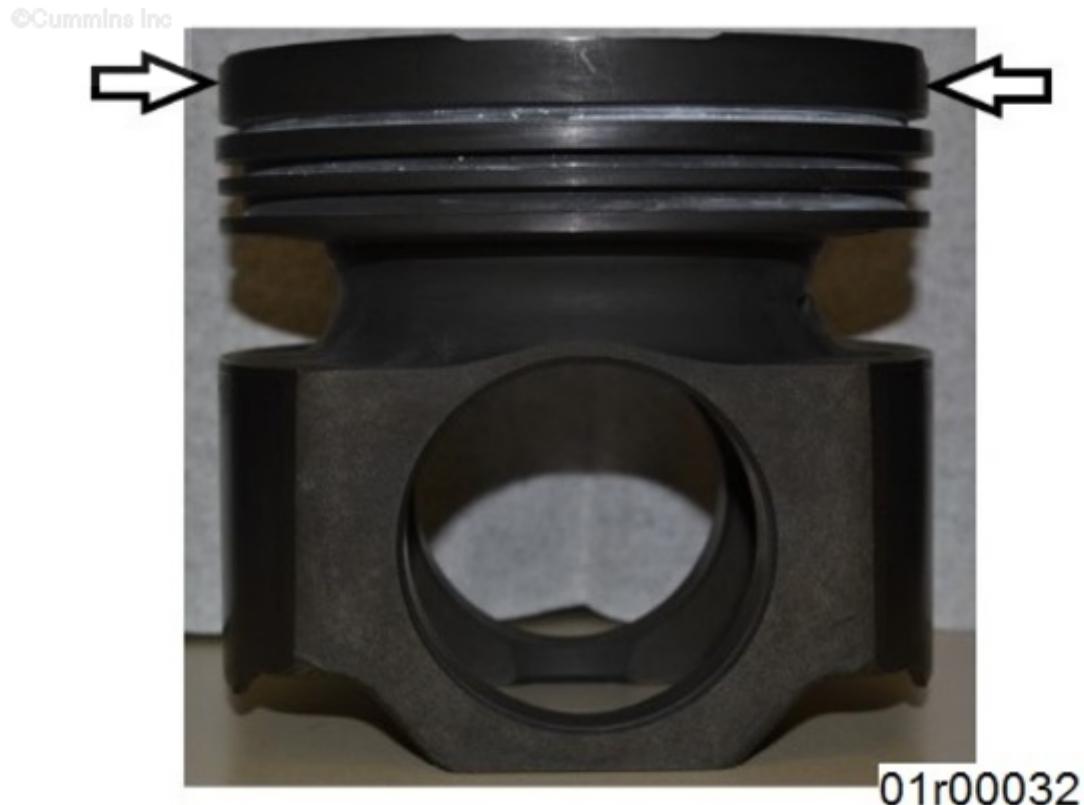
To identify a reduced diameter top land piston, measure the diameter of the piston land above the top ring. Reduced diameter top land pistons will measure  $134.86 \pm 0.05$  mm [  $5.309 \pm 0.002$  in ]. Non-reduced diameter top land pistons will measure  $135.30 \pm 0.05$  mm [  $5.327 \pm 0.002$  in ].

Figure 5, Measurement location to identify piston top land diameter

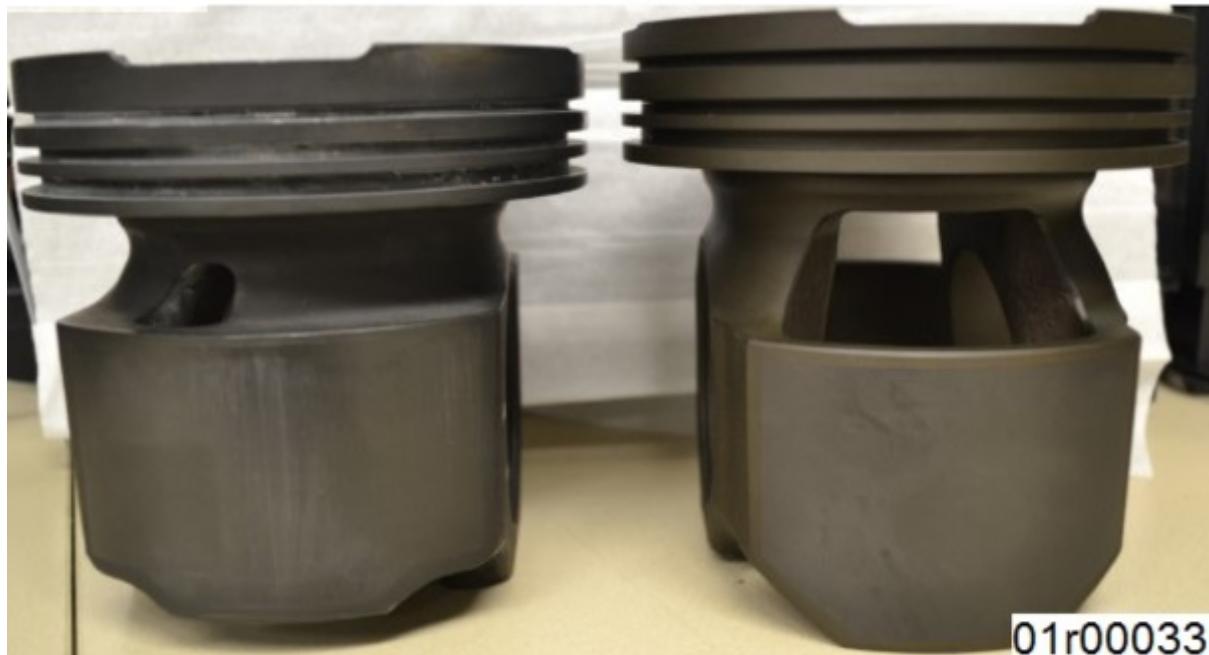
Use Figure 6 to identify an open skirt piston versus a closed skirt piston.

Figure 6, Closed skirt piston on the left and open skirt piston on the right
