Piston Carbon Packing

EXAMPLES

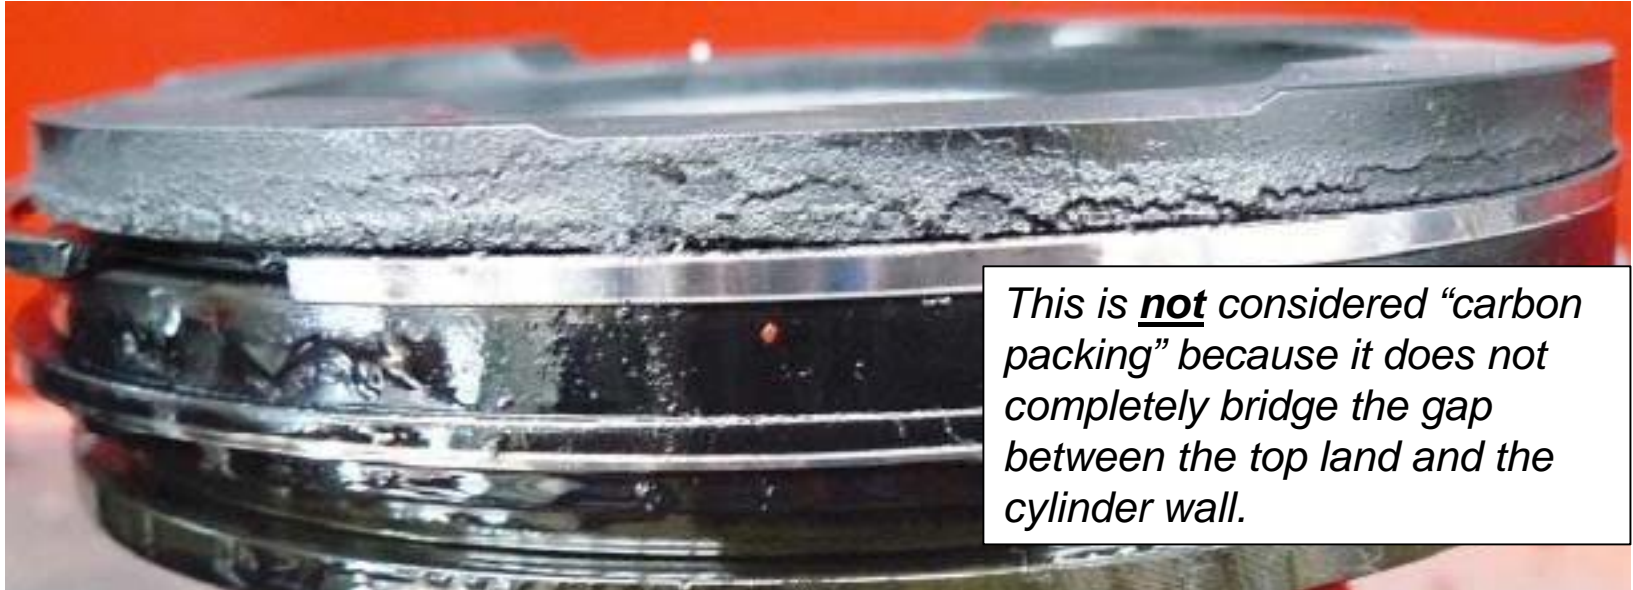
This is **not** considered "carbon packing" because it does not completely bridge the gap between the top land and the cylinder wall.

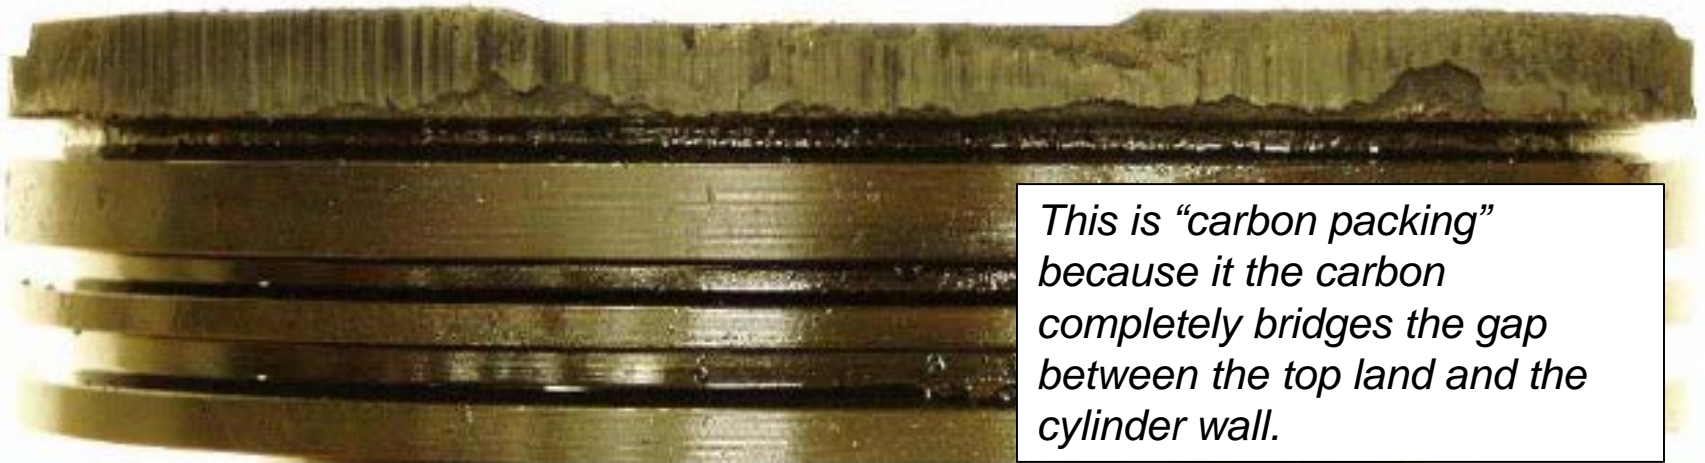
This is "carbon packing" because it the carbon completely bridges the gap between the top land and the cylinder wall.

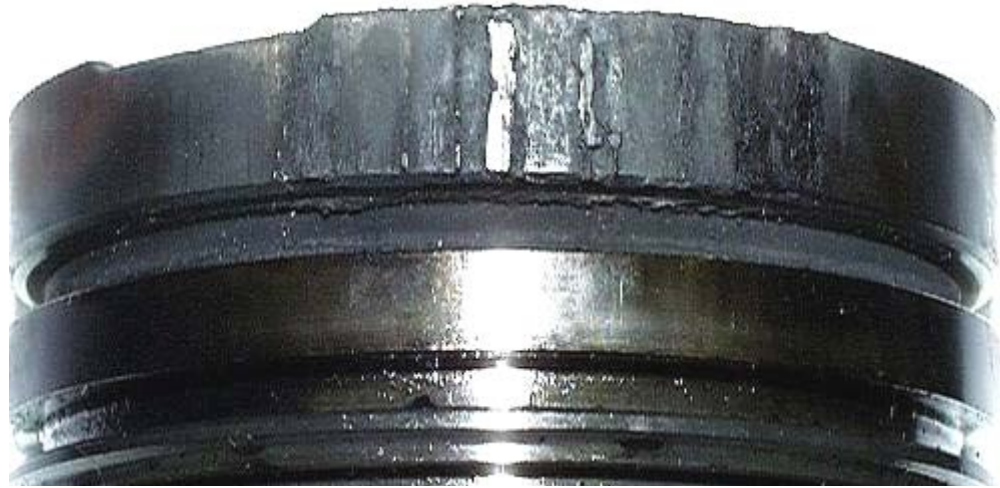
Effect of Carbon Packing

- ***Excessive Carbon Causes***
 - ***Lack of Oil Control***
 - ***Incorrect Piston Temps***

On ISX engines currently dealing with high levels of carbon packing (2013), are occasionally seeing very low blow by in the field. Carbon blocking combustion gasses potentially.

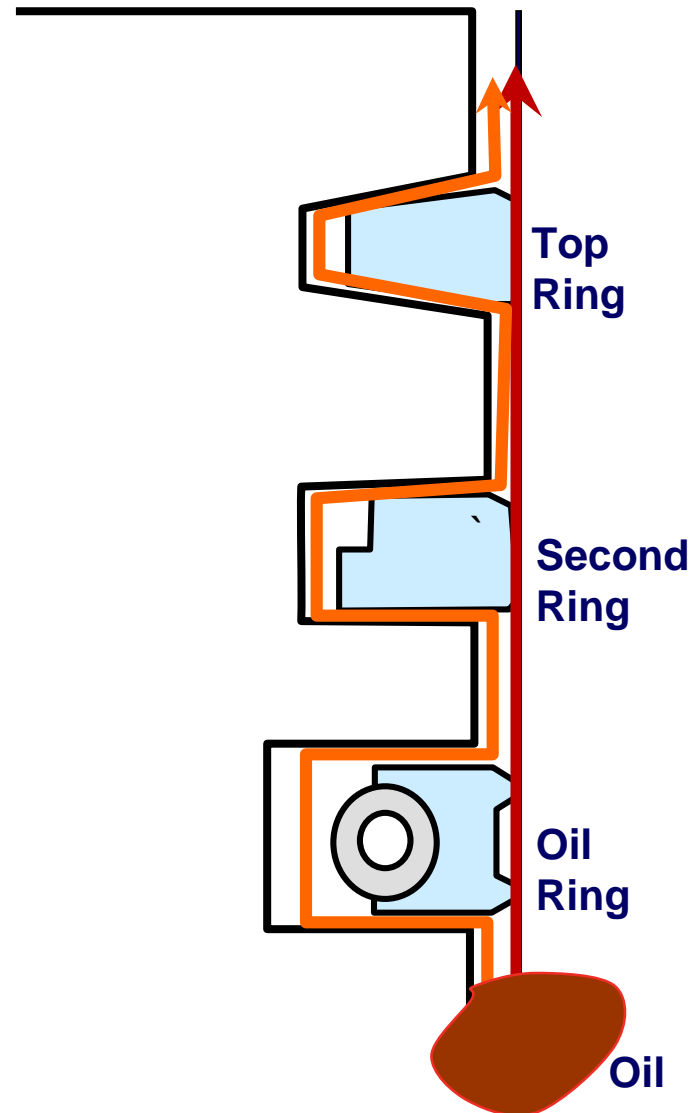
Oil Transport – Power Cylinder

- The ring need to seal oil from going up into the combustion chamber.

- Oil will move up past the face of the rings.
- Oil move up around the rings.

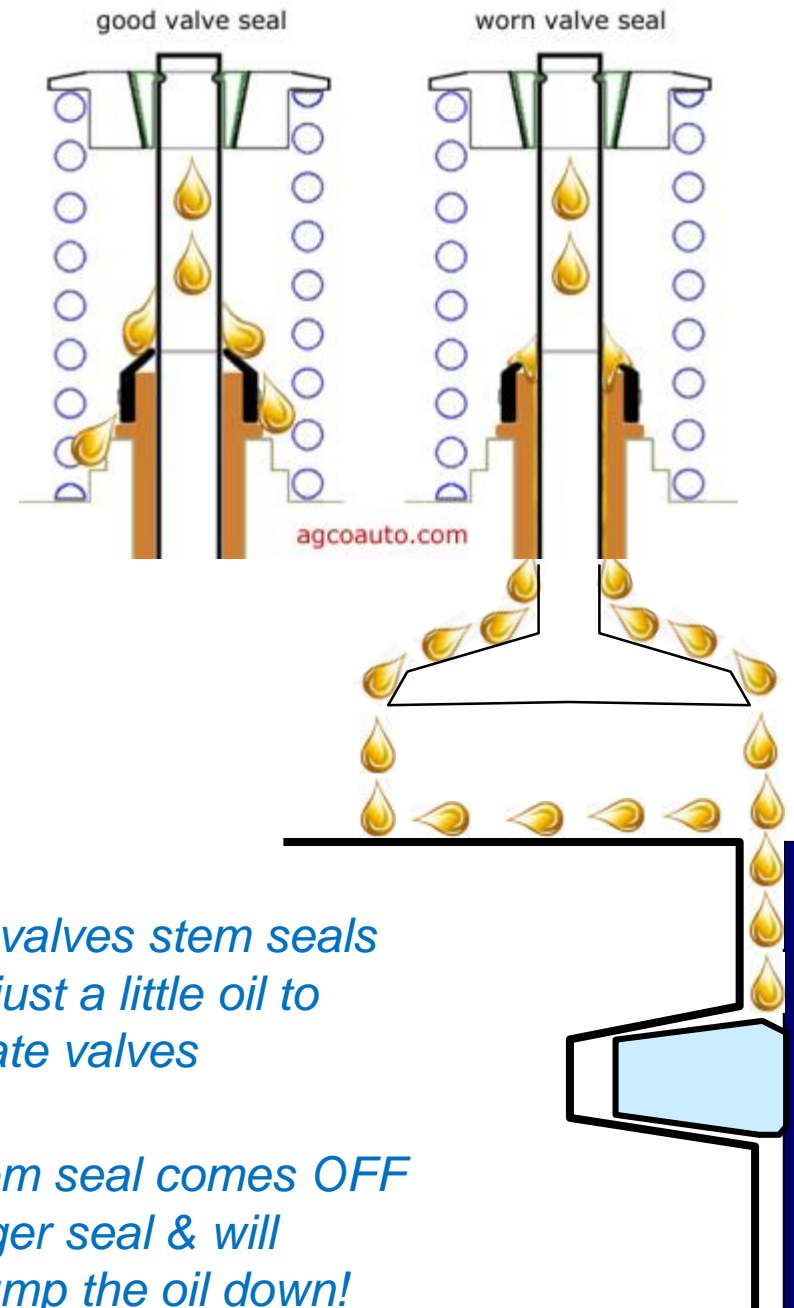
Oil Transport - Valves

- The valves need to seal oil from coming down into the cylinder.
- Intake Valve Stem Seals may not seal oil.
- Intake Valve Stem Seals may come OFF valve.
- Oil will go down the valves into the cylinder

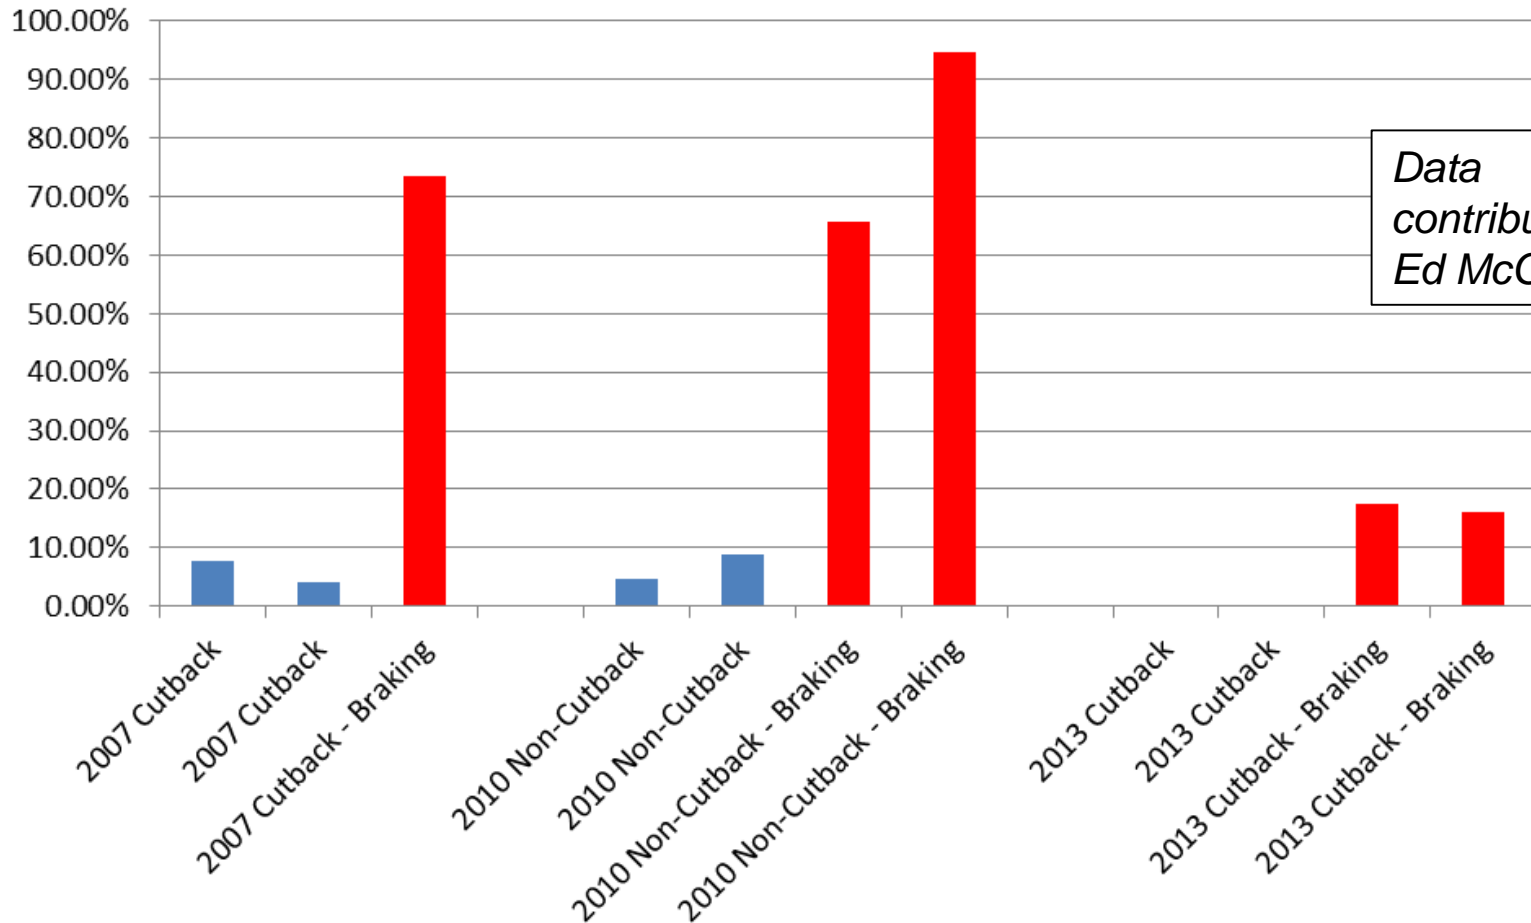
Effect of Engine Braking Carbon Packing

- Engine Braking will Create a Negative Pressure in the Cylinder
 - The energy that is created during compression is then released out of the exhaust valves.
 - Since all pressure is released, when the piston goes down to the bottom of the stroke it creates a vacuum.
- The Negative Pressure Will Suck Oil Upward
 - (Natural gas engines have this vacuum condition both at idle *and* during engine braking)
- Thus Increasing Oil Consumption and Carbon Packing.

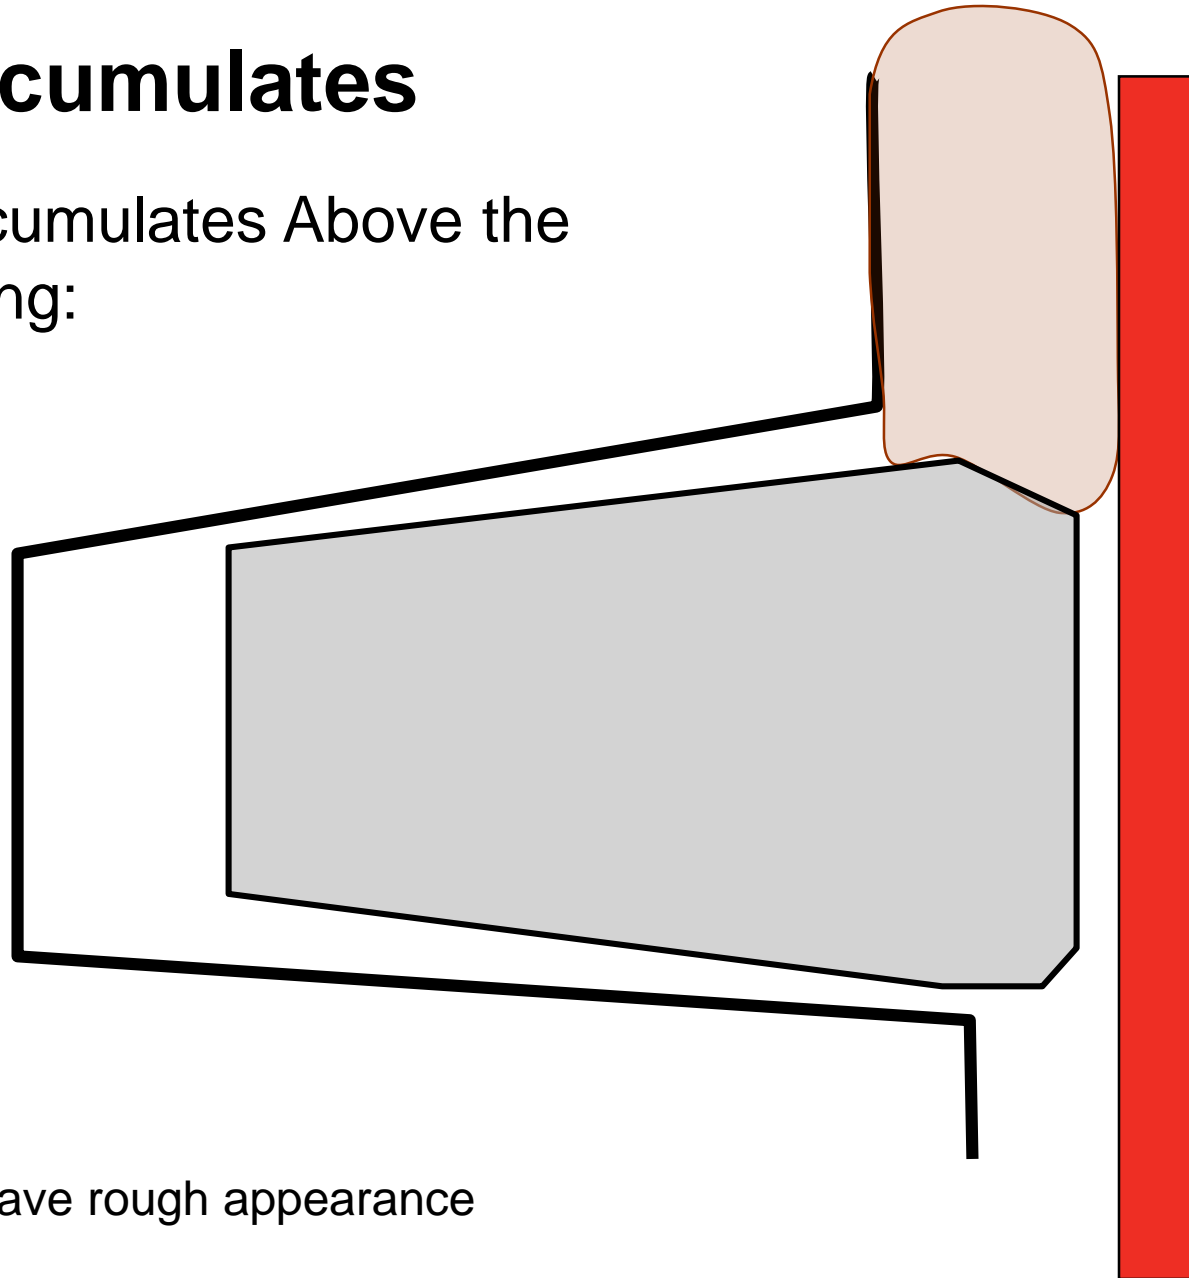
- Oil Accumulates Above the Top Ring:

Will have rough appearance

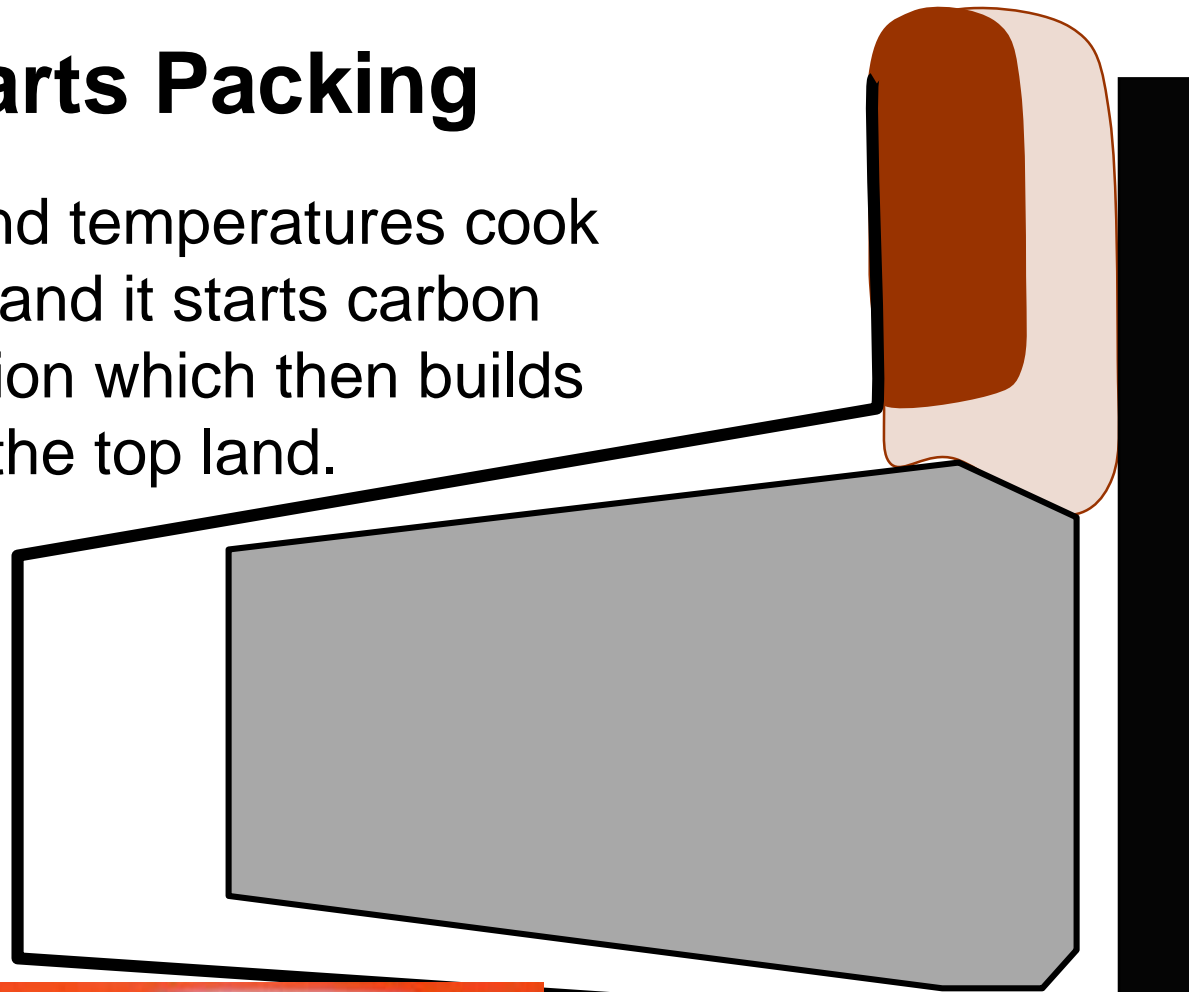
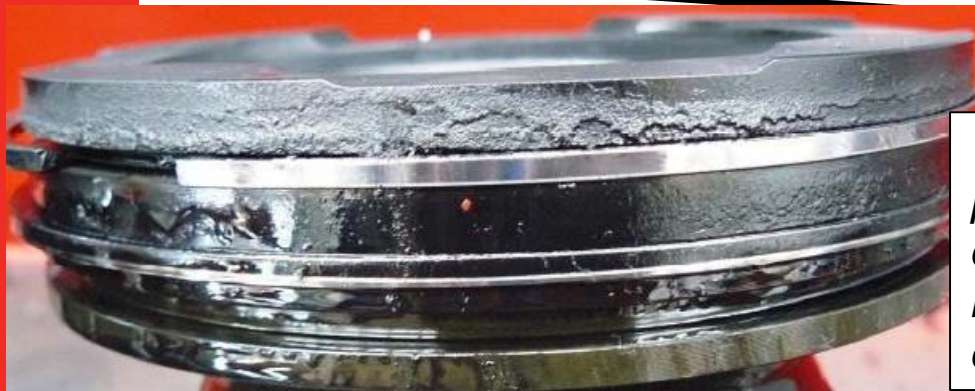
Oil Starts Packing

- Top land temperatures cook the oil and it starts carbon formation which then builds up on the top land.

*This is **not** considered “carbon packing” because it does not completely bridge the gap between the top land and the cylinder wall.*

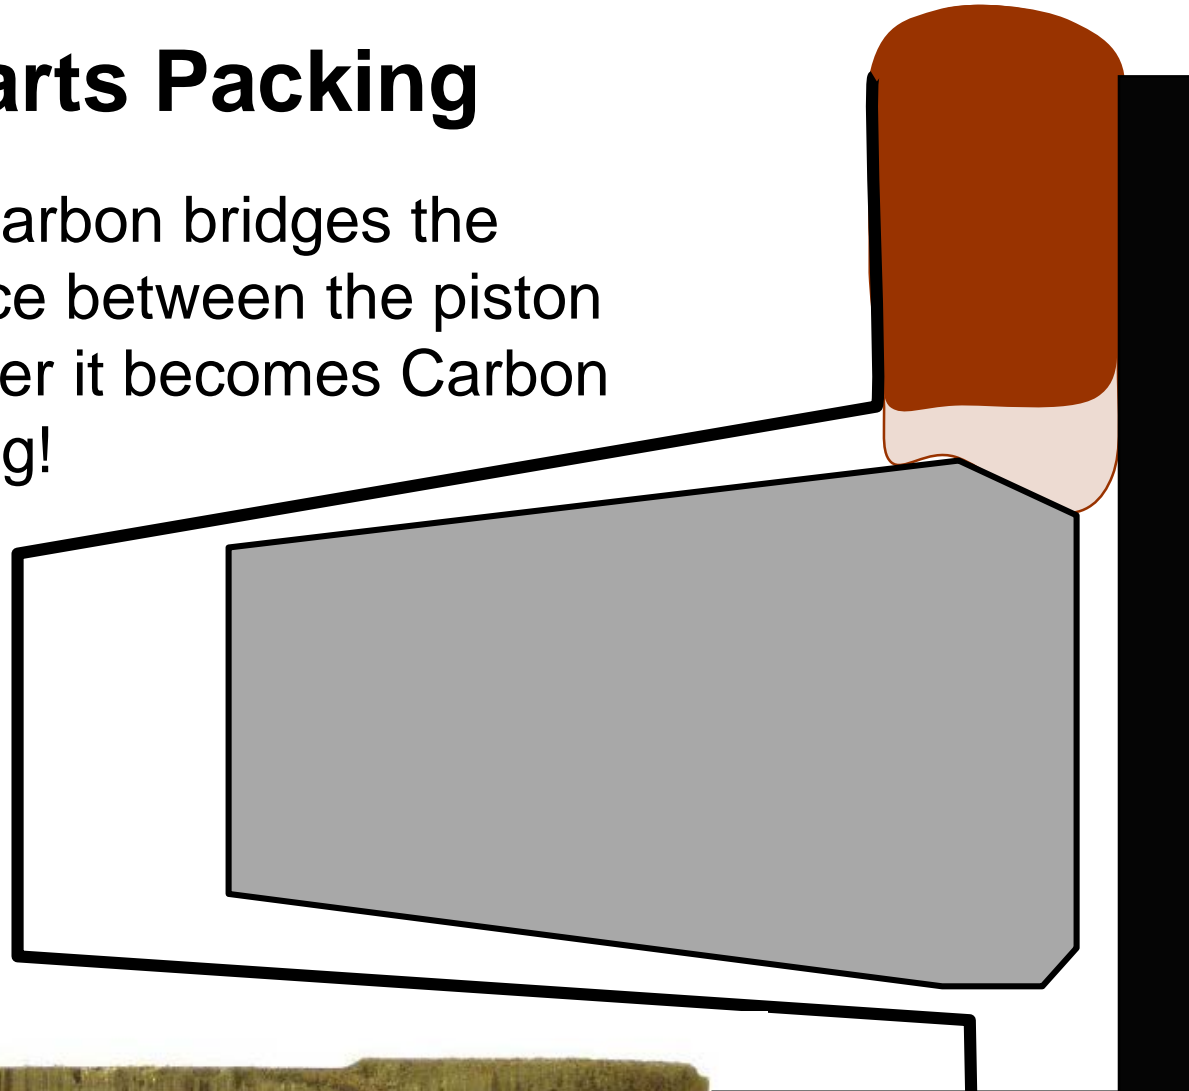
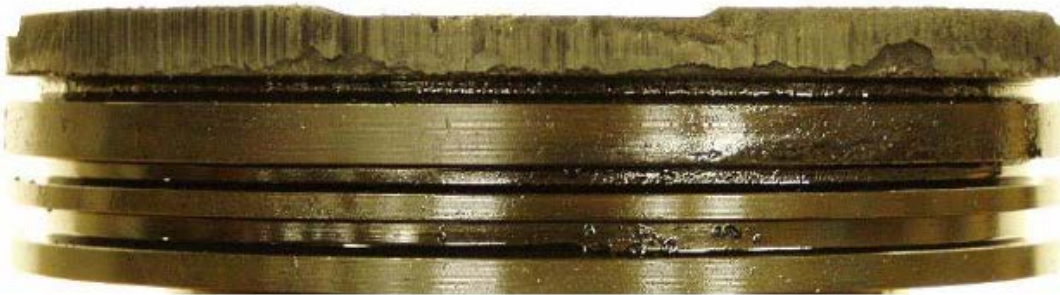
Oil Starts Packing

- If the carbon bridges the distance between the piston and liner it becomes Carbon Packing!

This is “carbon packing” because it the carbon completely bridges the gap between the top land and the cylinder wall.

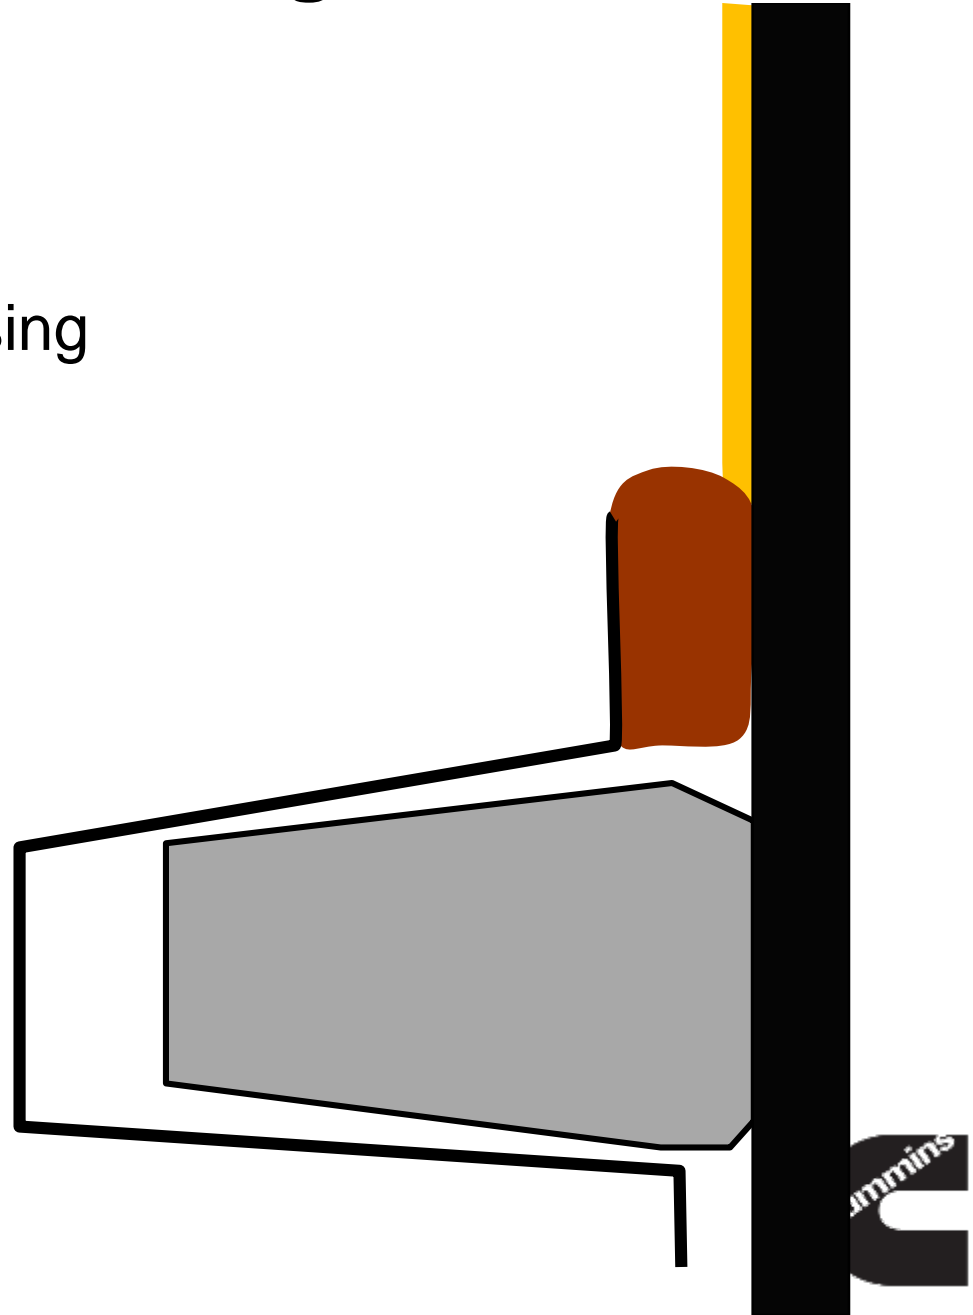
Theory 1: Oil Scraping

- Carbon Packing may scrape oil upward, causing high oil consumption.

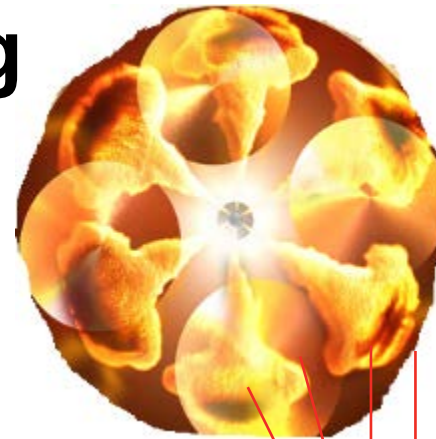
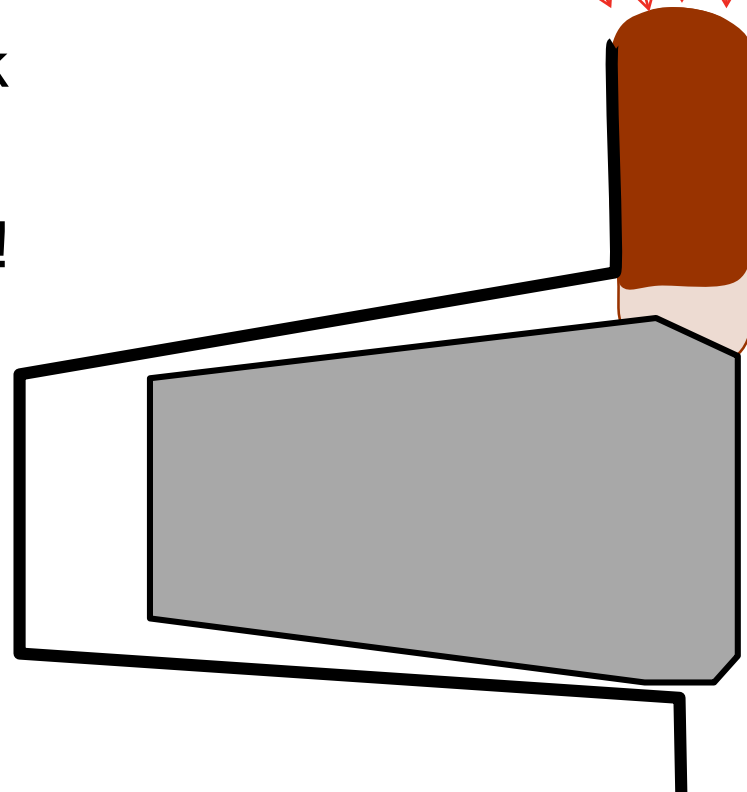
Theory 2: Energizing the Ring

- Carbon can prevent the pressure from getting behind the ring and energizing the ring!
- May affect the ring pack dynamics.
- The Rings Cannot Seal!

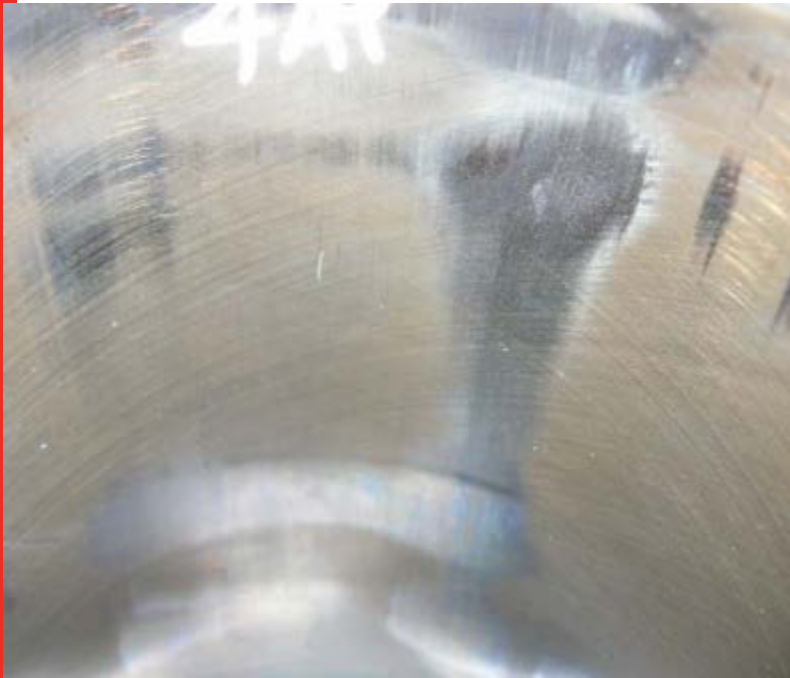
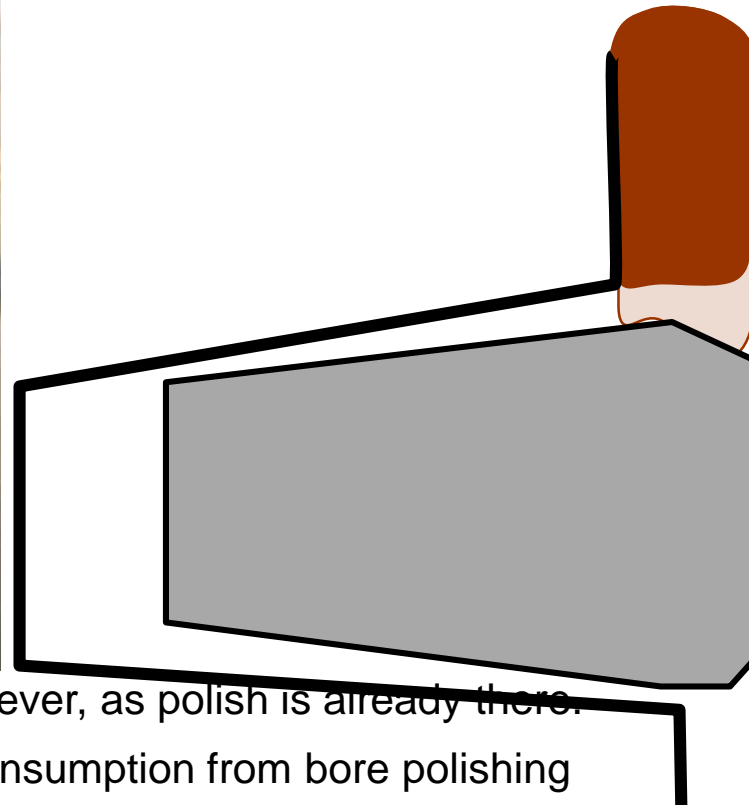
Theory 3: Bore Polish

- Carbon Can Polish the Bores.
As a result, the OC will be high because the rings cannot scrape the bore efficiently.

Cleaning the carbon here would not fix this however, as polish is already there.
Could be up to 100k miles before you see oil consumption from bore polishing though (ISX)

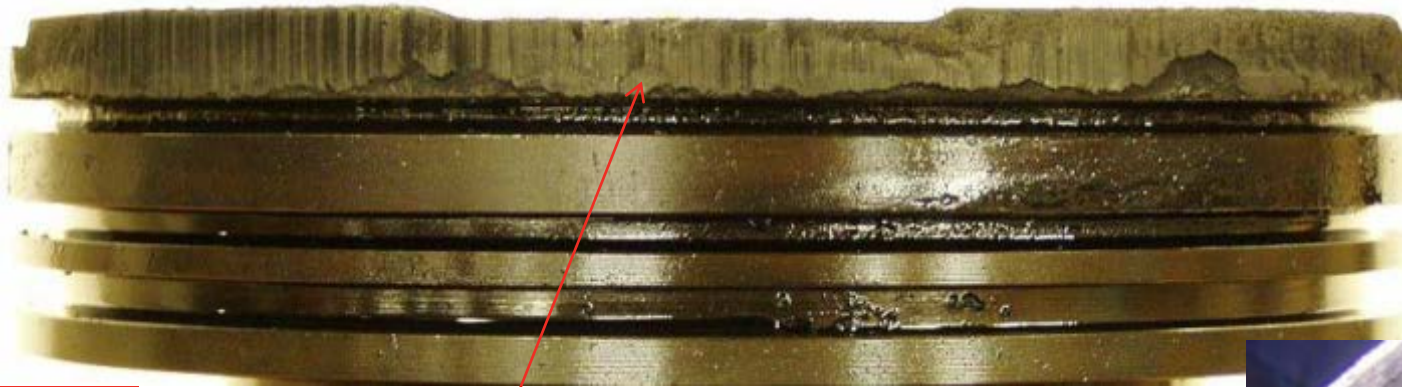
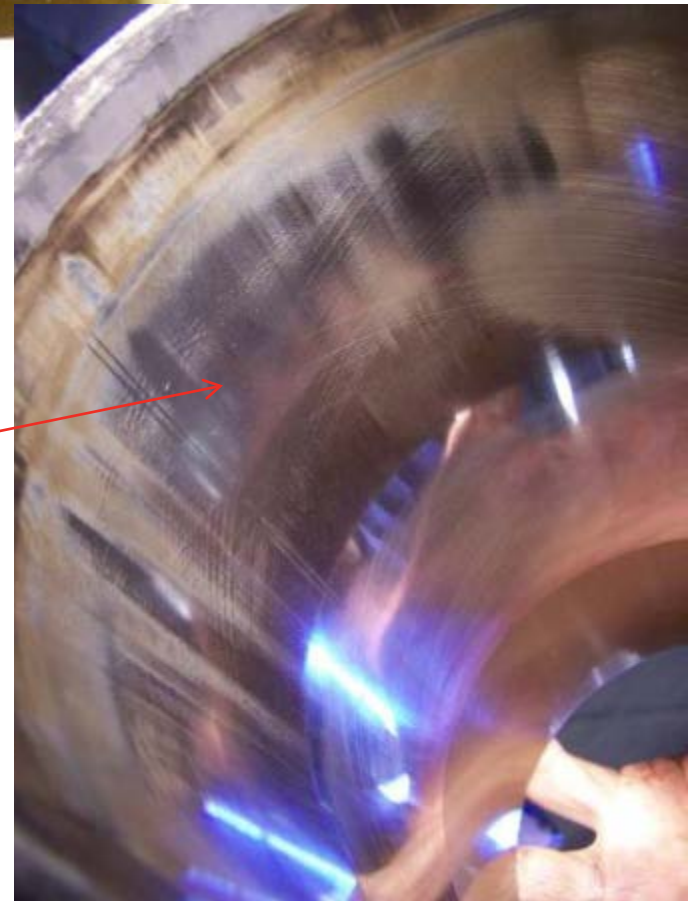
High Oil Consumption Piston and Liner

Carbon Packed
Top Land

Bore Polish
Through Cross
Hatch from Piston
Carbon Rubbing

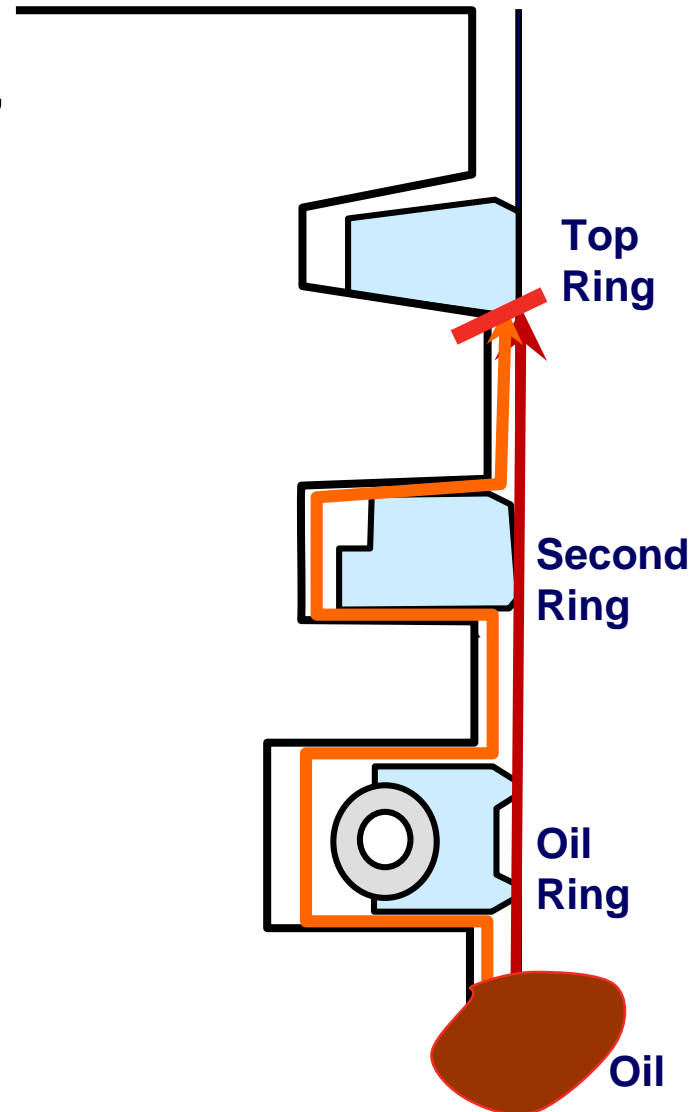
Block Oil Going Up

Not certain that you can fix oil consumption with this, it will help, but not eliminate.

There are no perfect seals. Any oil that gets past the rings can cause carbon packing.

Land cut-backs are not shown here, but can be very important in giving oil a place to drain. Just need to be sure there is enough support for the rings!

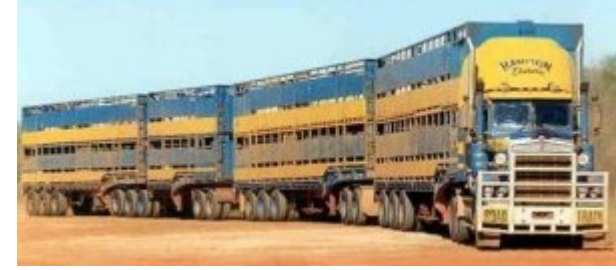
Temperature

- Highly loaded applications do not tend to form carbon packing as much as the lighter applications.
 - Large road train trucks in Australia did not form carbon packing
 - However the coolant systems in are designed for the heavy loads. As a result, the engines run cooler than run lighter loads..
 - Carbon packing is very bad on the lighter loaded engines.

- If the temperatures are high enough, the carbon will burn off.
- If the temperature is low enough the carbon will not form.

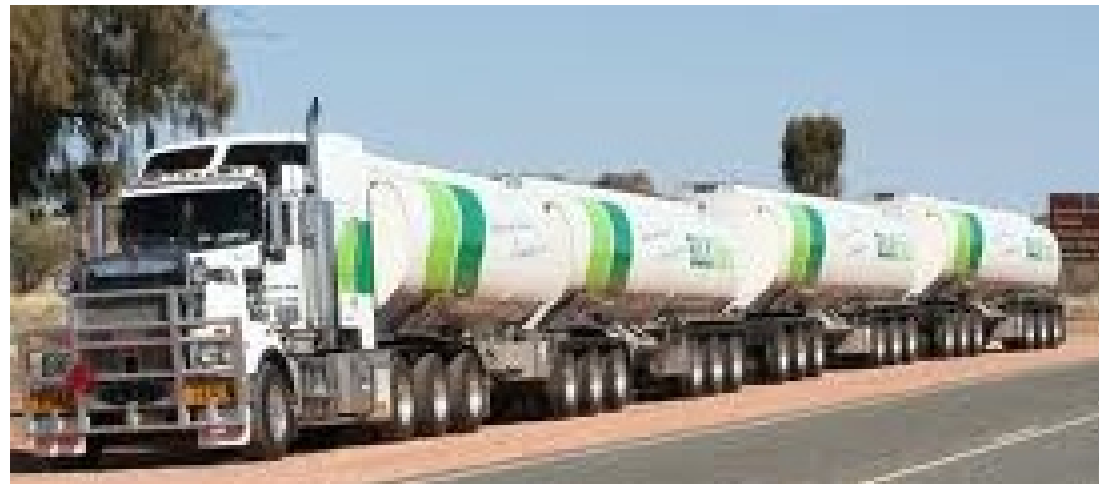
Duty Cycle

- Engines with highly cyclic loads tended to have high carbon packing
 - Theory: Oil transfers to the top land during light load. At higher loads it bakes the oil.
 - Example.
 - Engine would load up coal and travel very highly loaded to deliver the coal.
 - The mine is at the top of the mountain. As they went down the mountain, they would use **engine brakes** very heavily.
 - After delivery, it would return unloaded.

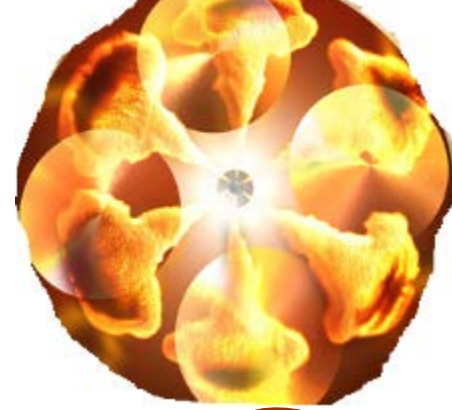
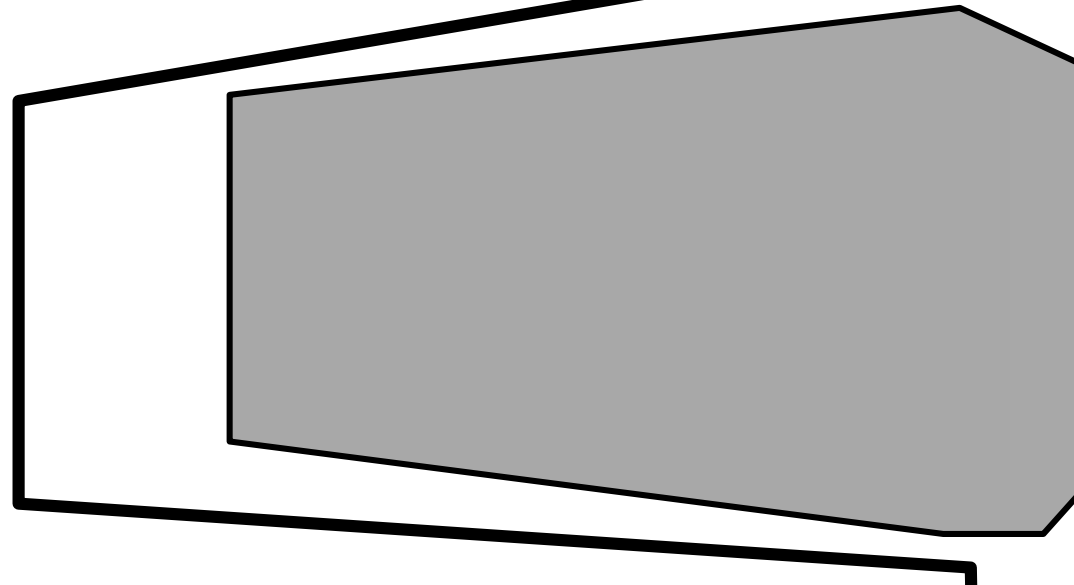
Top Land Cut Back

- If the top land clearance is large enough, then the combustion can burn the carbon.

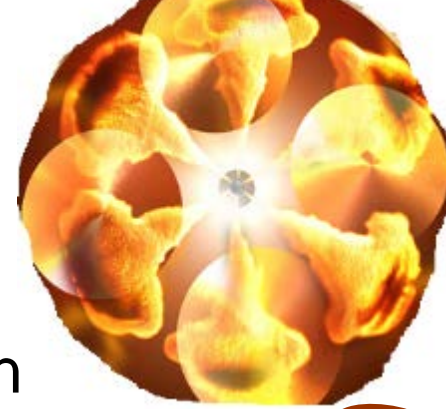
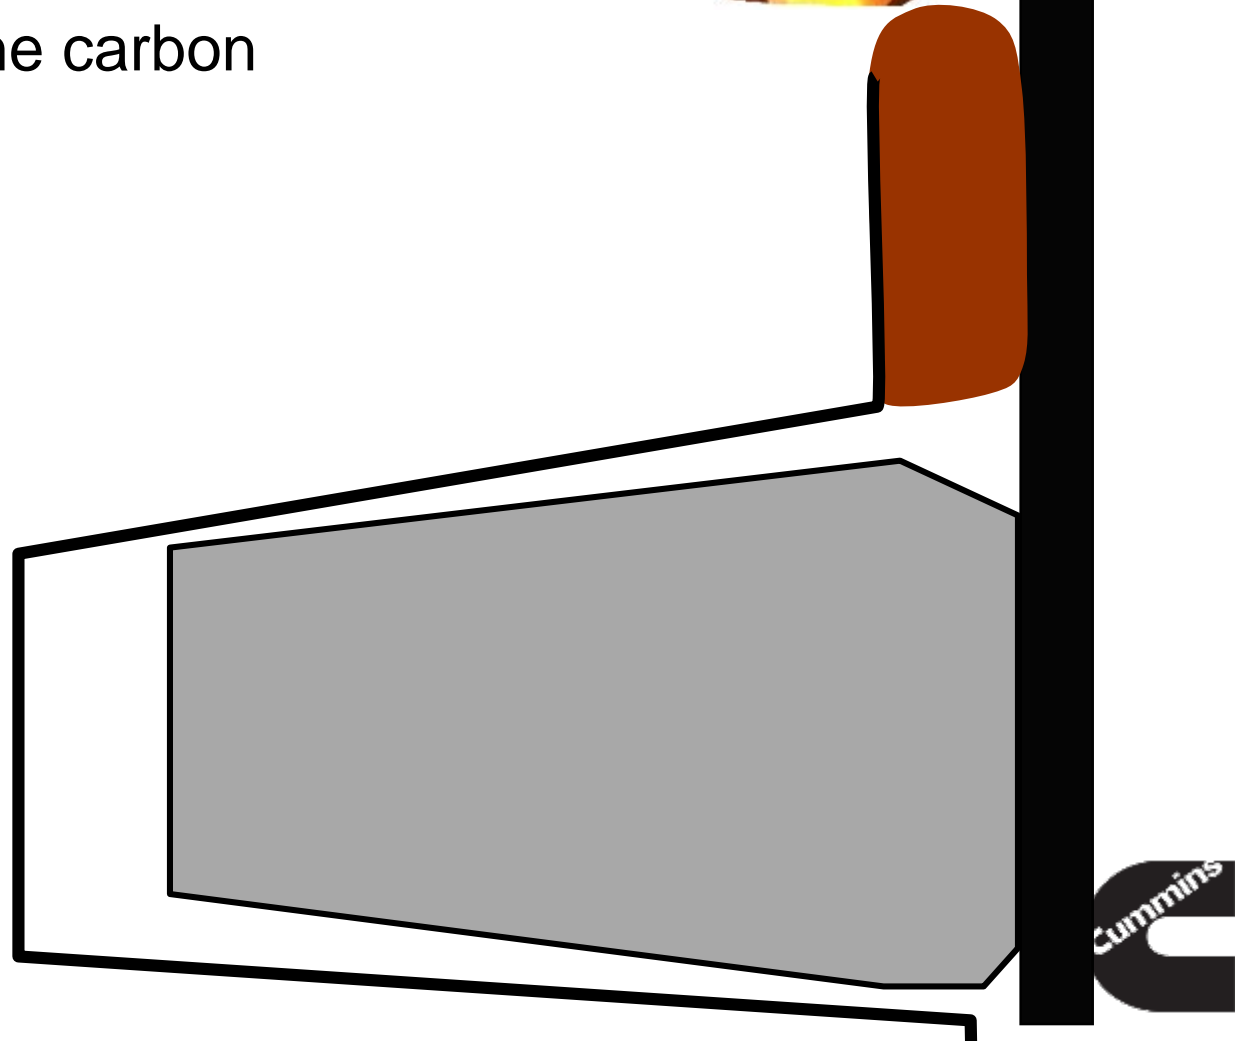
Top Land Cut Back

- If the top land clearance is too small enough, then the combustion cannot burn the carbon

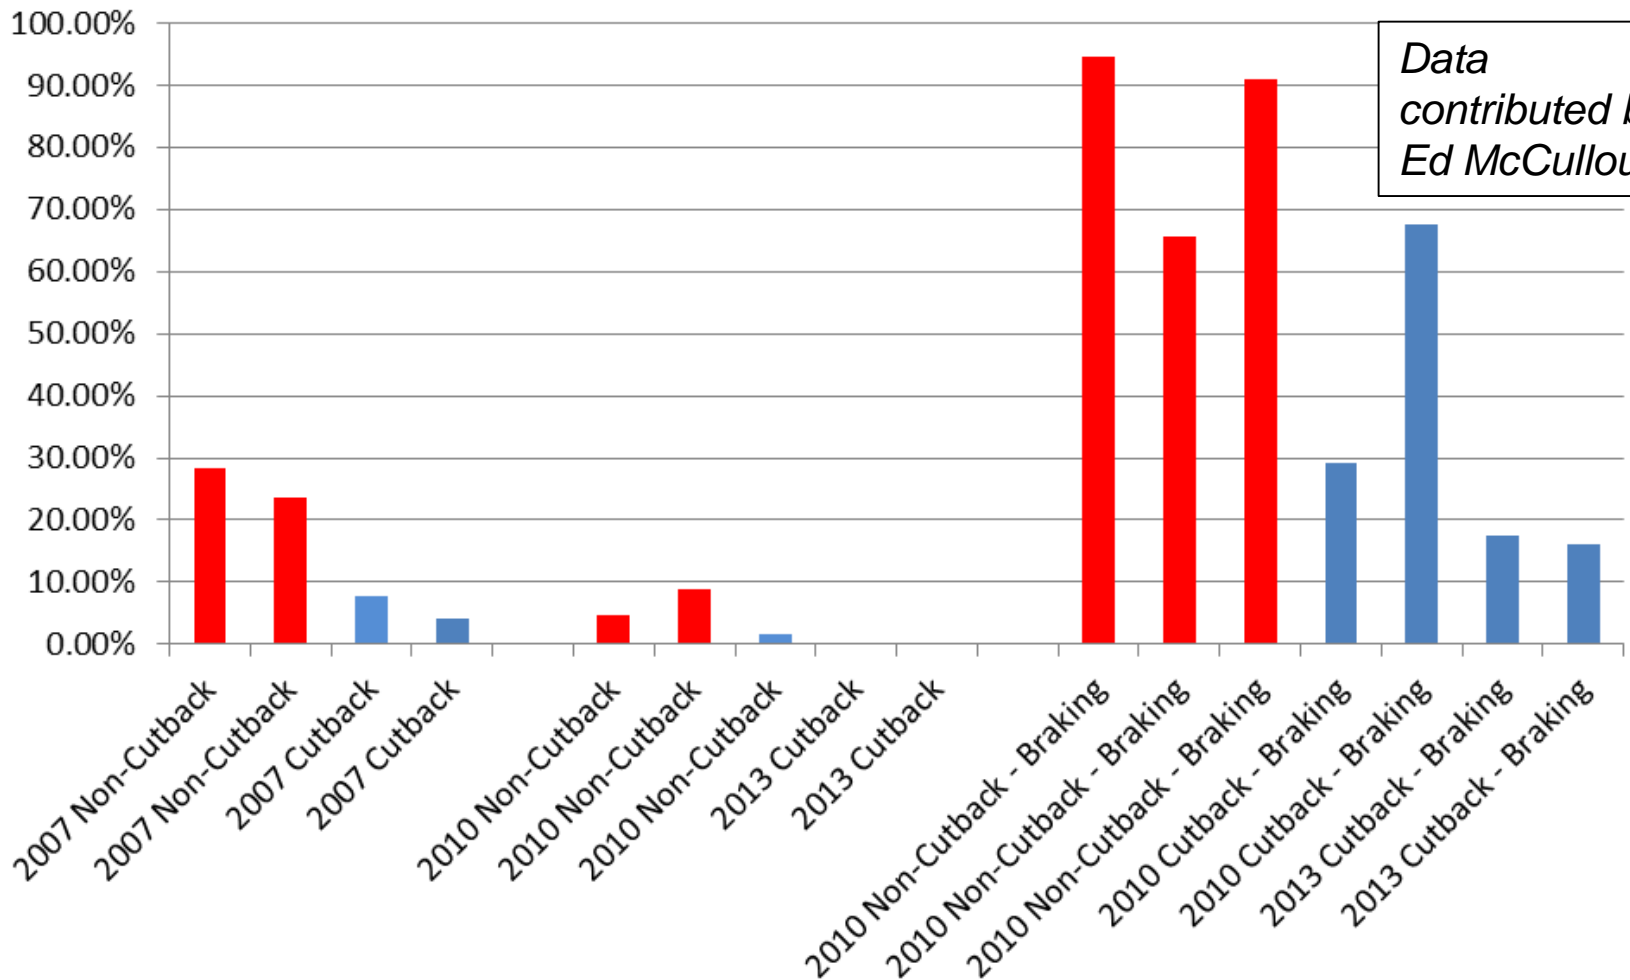
Effect of Top Land Cutback on Carbon Packing

- As you increase the clearance on the top land, the carbon packing disappears.
 - JEP study looked at a design starting with small clearance and carbon packing, then ISX went to a tapered land, then increased cut back up to a “magic” clearance, and at that point carbon ceased forming!
 - Other fixes to carbon packing were implemented, fixed some, but then the issue came back in the field.
- This increased top land clearance was found as a fix in 2009 after many failures, and much cost.
 - **However**, the larger top land cut-back is something that CPE is reluctant to implement. Transparent to emissions in some cases, but perhaps not in others... could be measureable noise.
 - Also, during next-gen development testing, carbon packing not found in test cells, so cut-back was not implemented, and failures came BACK!
 - ***NEED TO ALWAYS HAVE THIS CUT BACK***

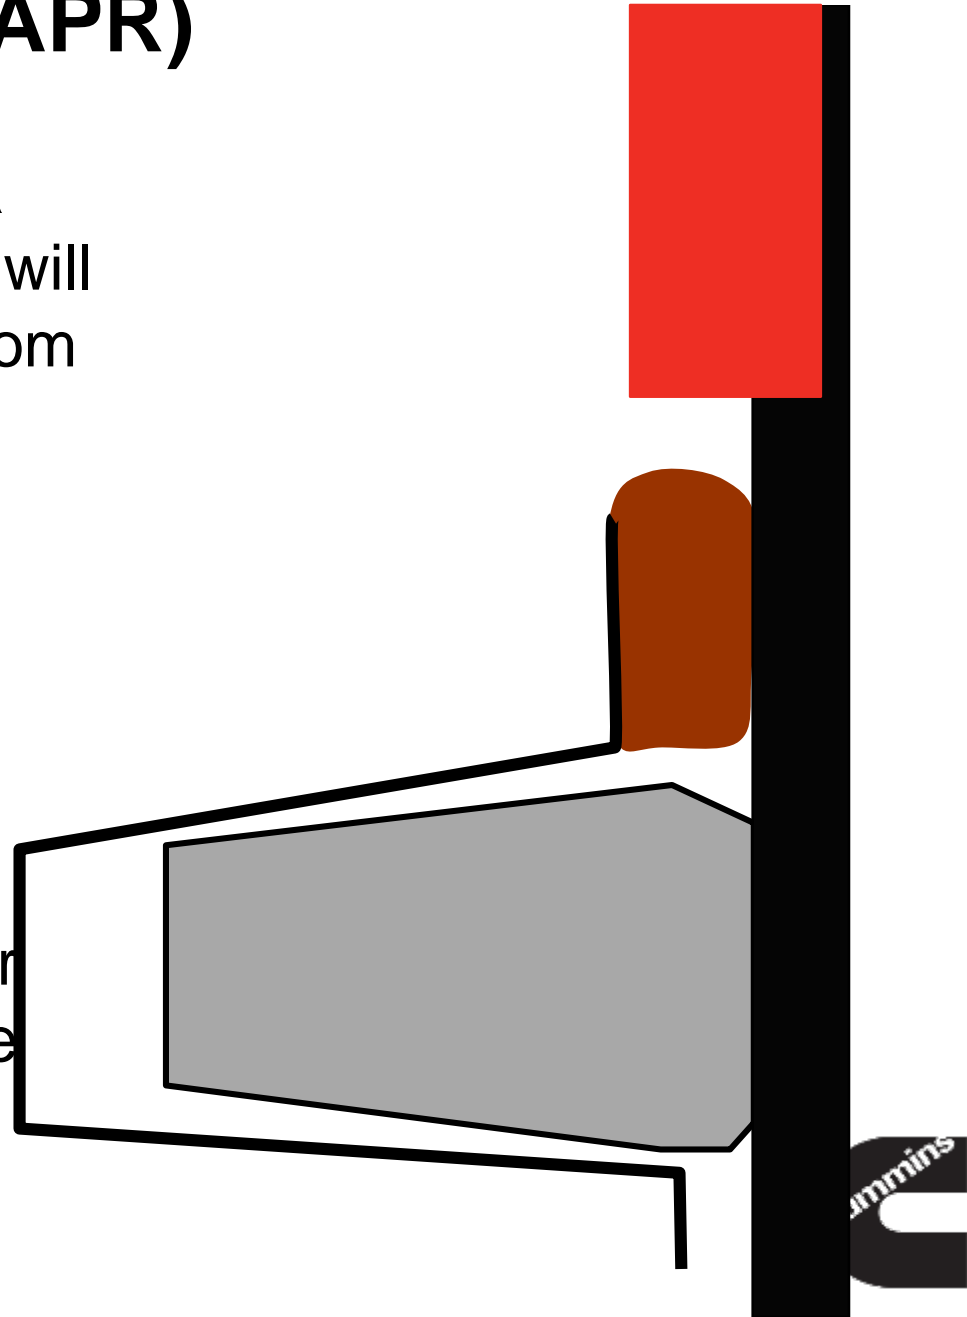
Anti Polish Ring (APR)

- One solution is to add a scraper to the liner that will scrape off the carbon from the top land.
- It is placed above Top Ring Reversal
- Possible Problem: It scrapes carbon down which may cause higher wear of the liner and the top ring face.
