Piston Carbon Packing

EXAMPLES

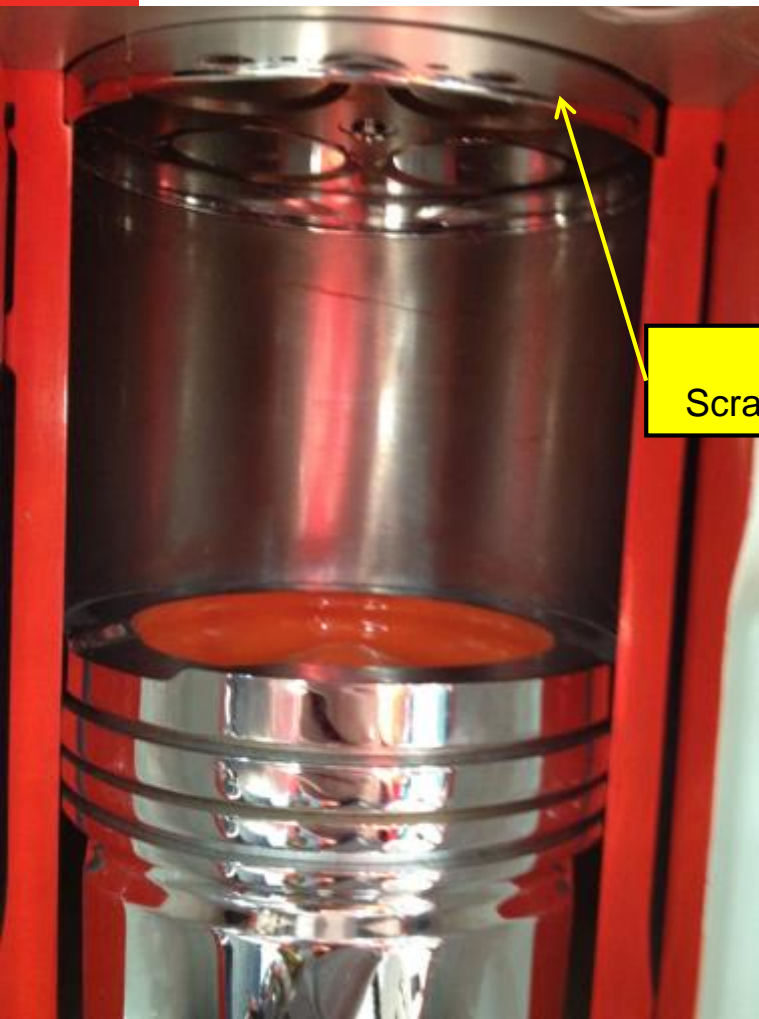
2013 Detroit Power Cylinder

■ Piston Carbon Scraper

- New for 2013.
- Advertised for Fuel Economy and Oil Consumption.
- Expect oil consumption is the main driver.
- Estimated at \$50/engine cost.
- Scania also going this way for all new engines due to oil consumption.

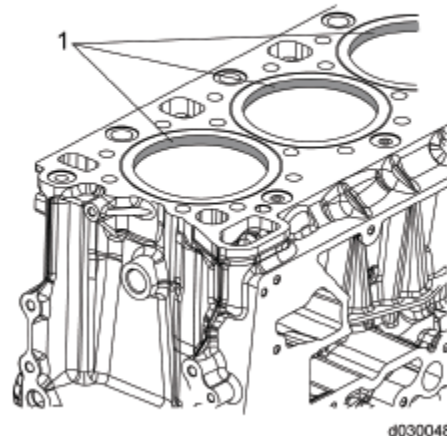
6. Use Scotch-Brite® pads to remove any carbon deposits from the upper inner surface (1) of the cylinder liner.

7. For GHG14 engines, remove the Carbon Scraper Ring on the inner diameter of the cylinder liner.
8. Remove the piston oil spray nozzles (1) from the base of the cylinder bores and discard the nozzles.

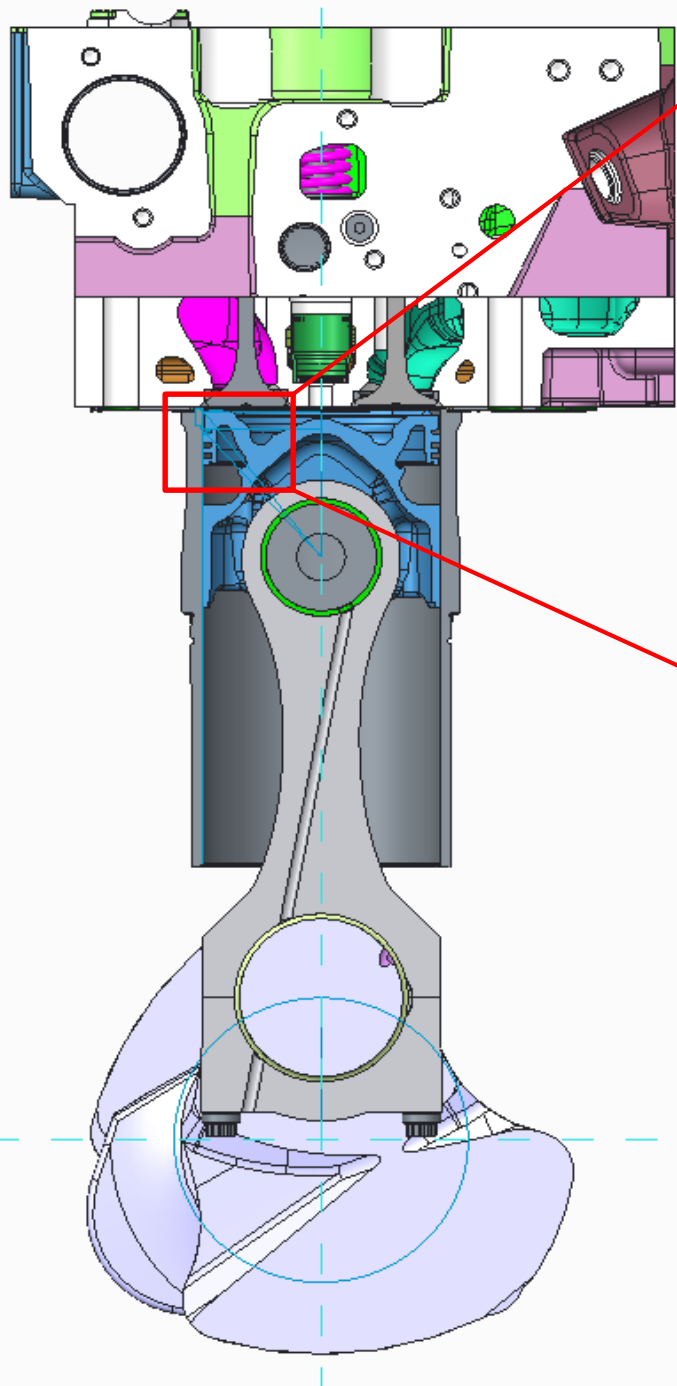
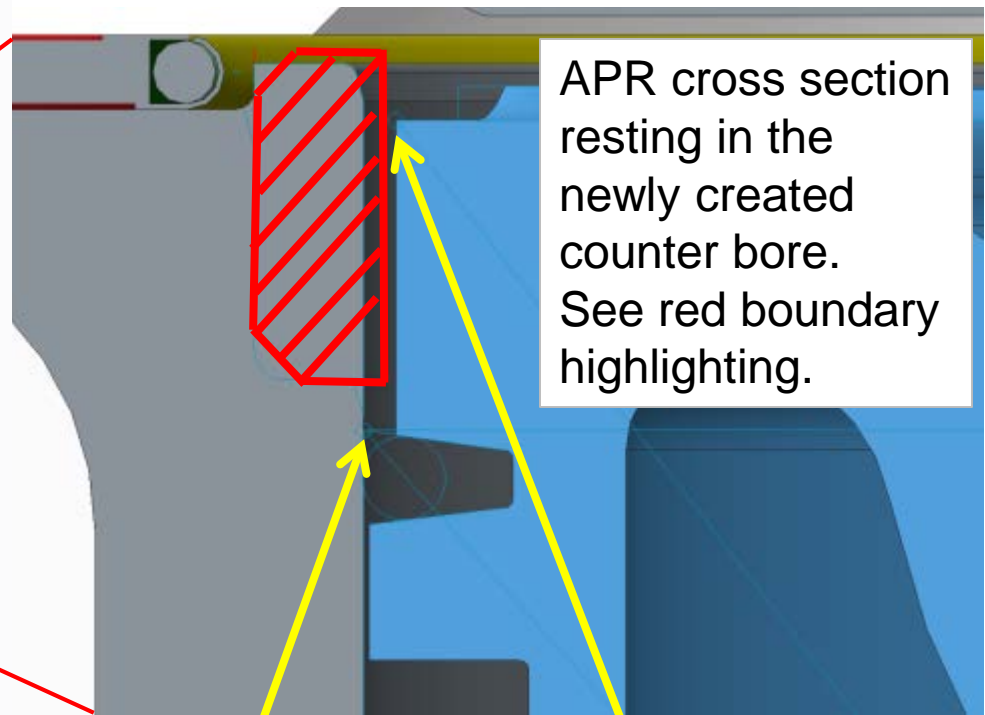
APR cross section resting in the newly created counter bore. See red boundary highlighting.

Theoretical uppermost extent of ring

Upper corner of piston.

Primary design hurdles for Anti-polishing ring (APR): (Target 8/16/13)

- 1) Avoid top ring to APR contact
- 2) Avoid upper piston corner contact
- 3) **Min clearance = min carbon!**

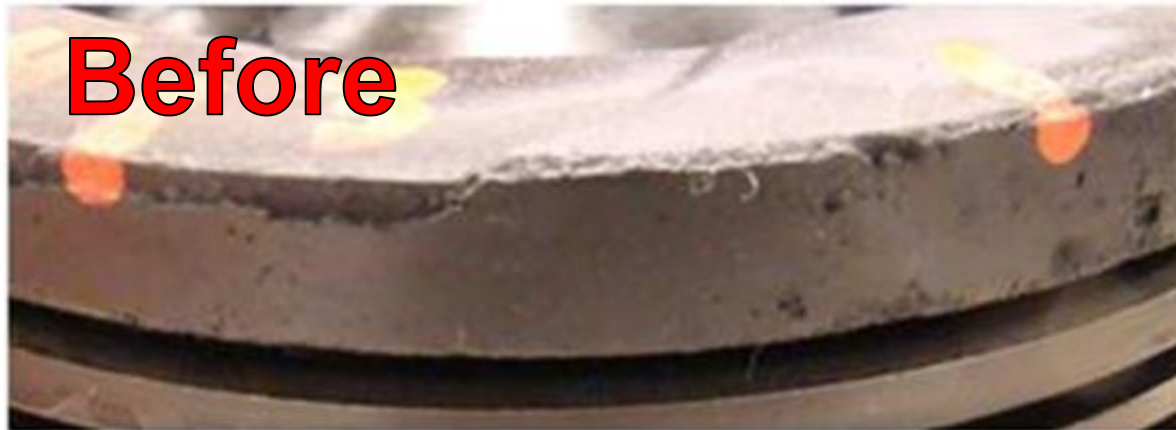
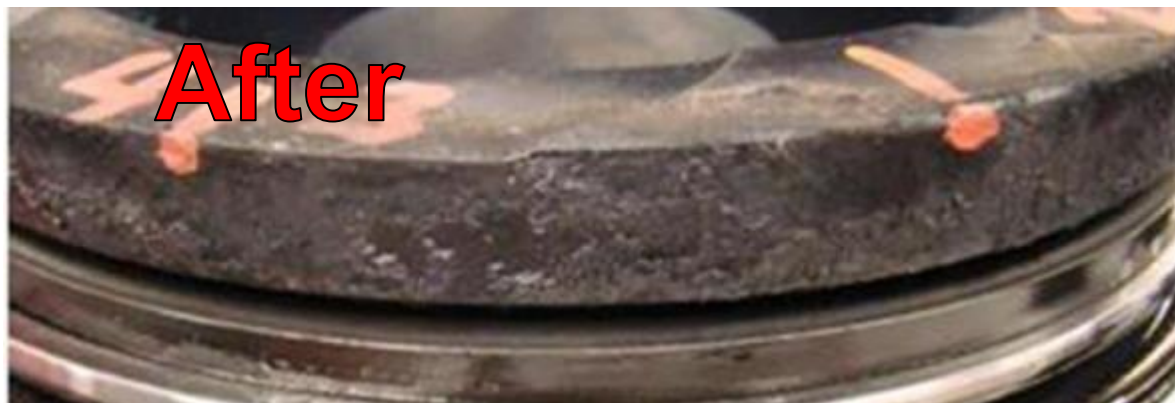
Effect of Water Injection

Water injected thru the intake manifold to clean the carbon off the top of the piston.

84.5% reduction in piston top land carbon packing

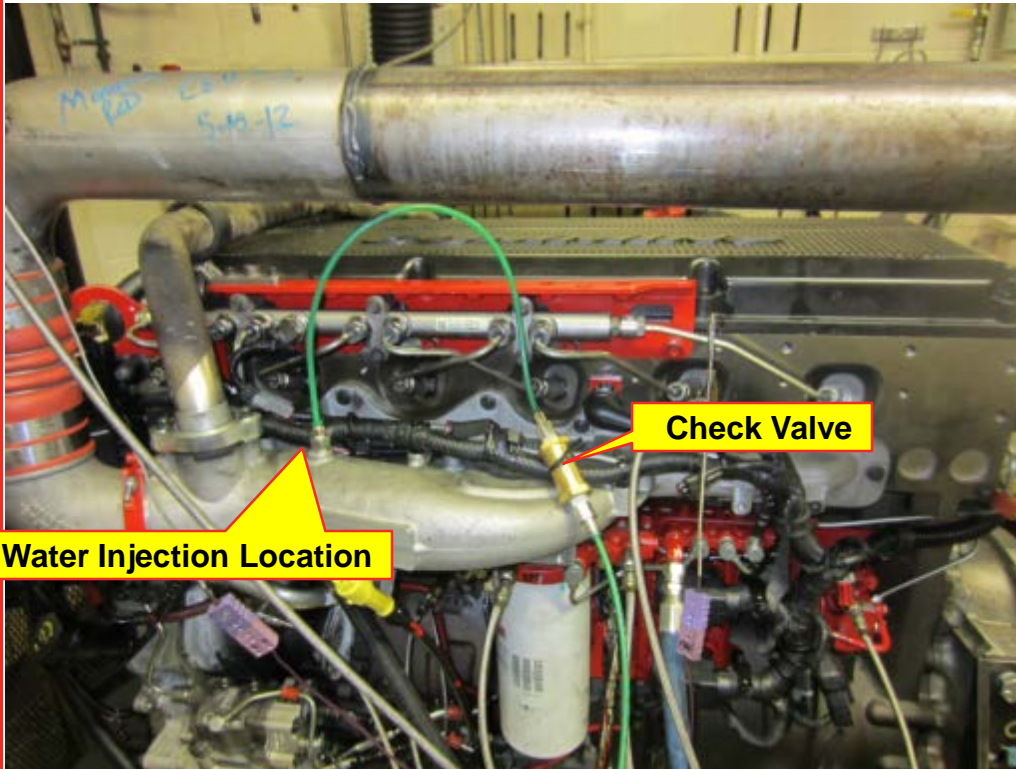
Water Injection Setup

Water injection nozzle sized for 3.3 GPH flow rate

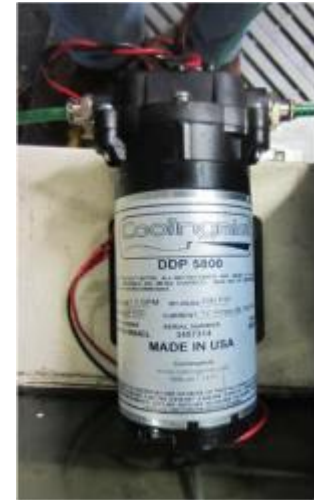
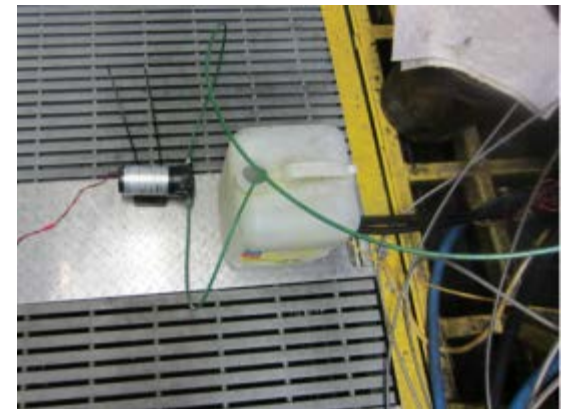
12V Pump

Pumps water at 200psi from a 4 gallon supply bucket.

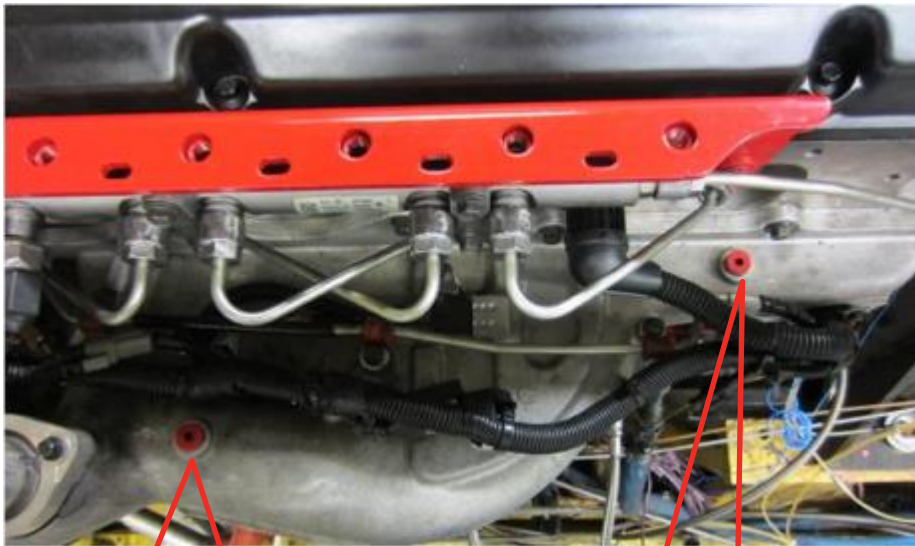
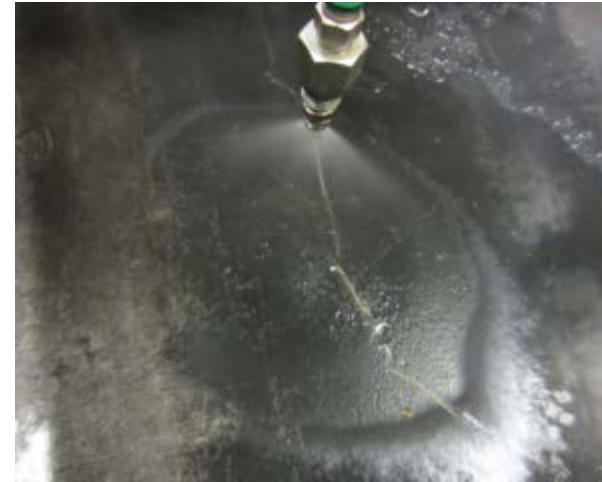
Water Injection Setup

1. Plumb boost pressure switch into the intake manifold port 2 as a **failsafe against water injection while engine is not running**.
2. Disconnect crankcase breather inlet hose. Route hose from valve cover or gear housing fitting into a bucket.
3. Disconnect the after treatment at the inlet fitting and direct exhaust flow in a safe direction into a vent.

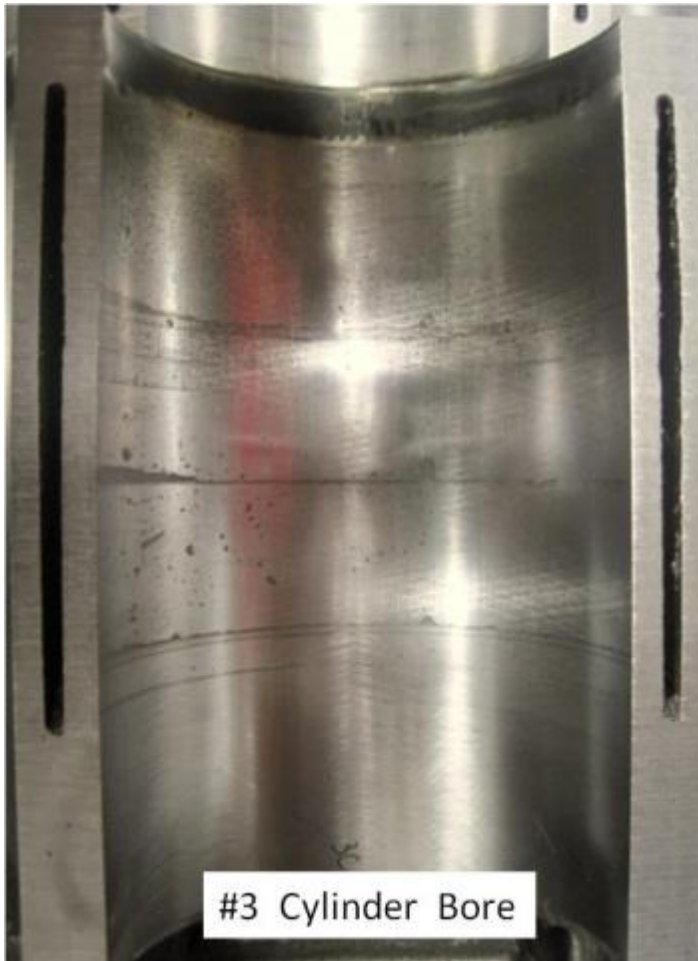
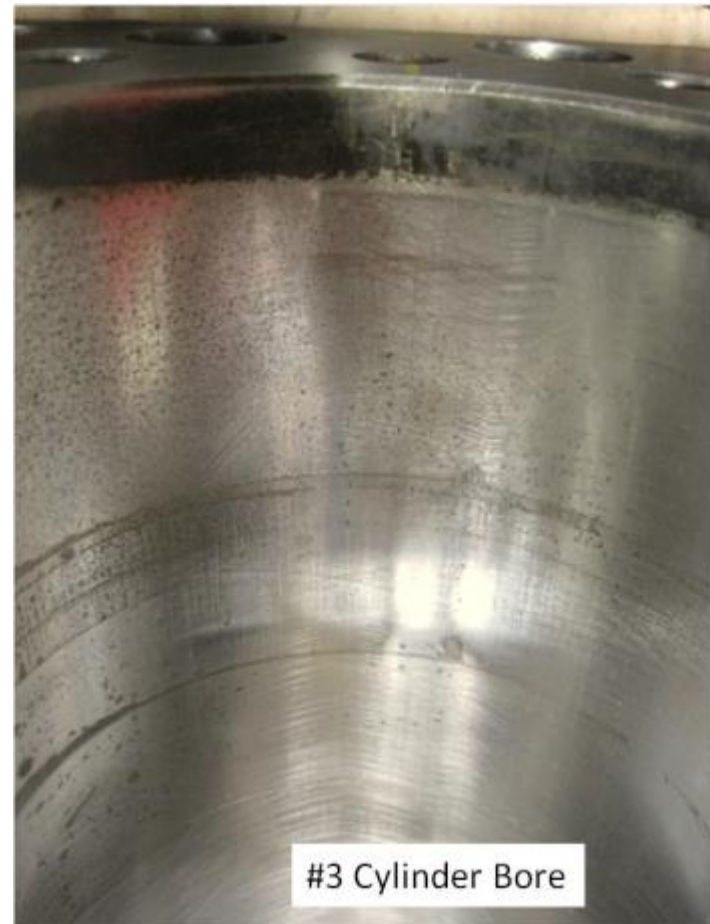
Rusted Cylinder Bores

Water was able to get in engine (intake), then sat for ~ 1 year.

- Rust in the cylinder correlated with very high piston ring wear *Engine was built, not needed right away. Stored, but not correctly (not sealed up correctly!)*

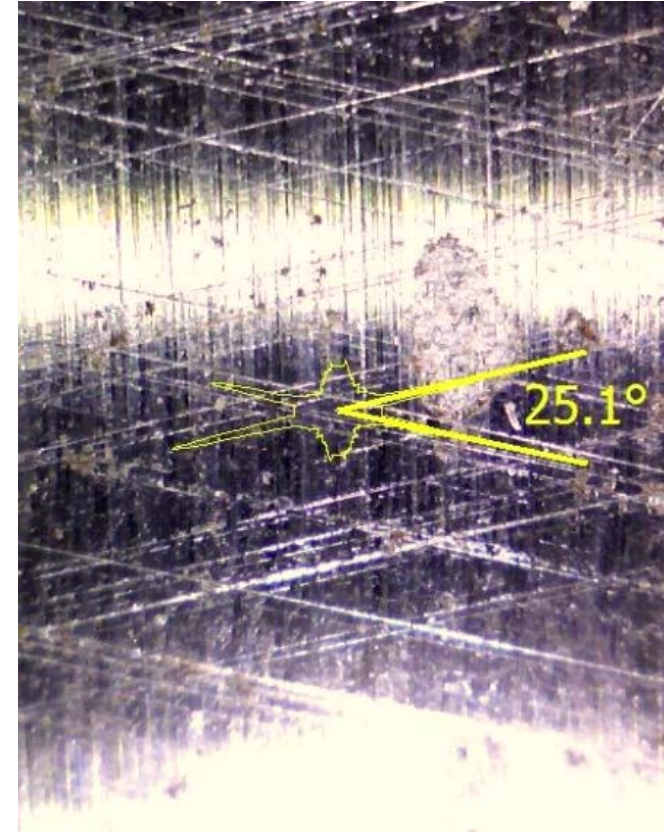
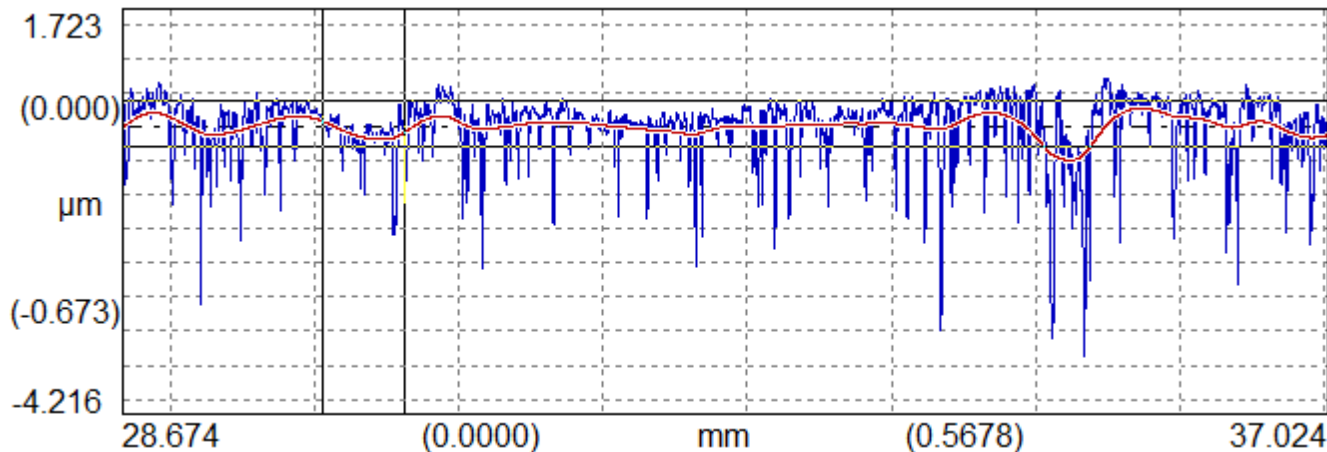
Rusted Cylinder Bores

- Rust creates holes in the cylinder
- It is thought that the holes in the liner caused by the rust resulted in excessive ring wear.

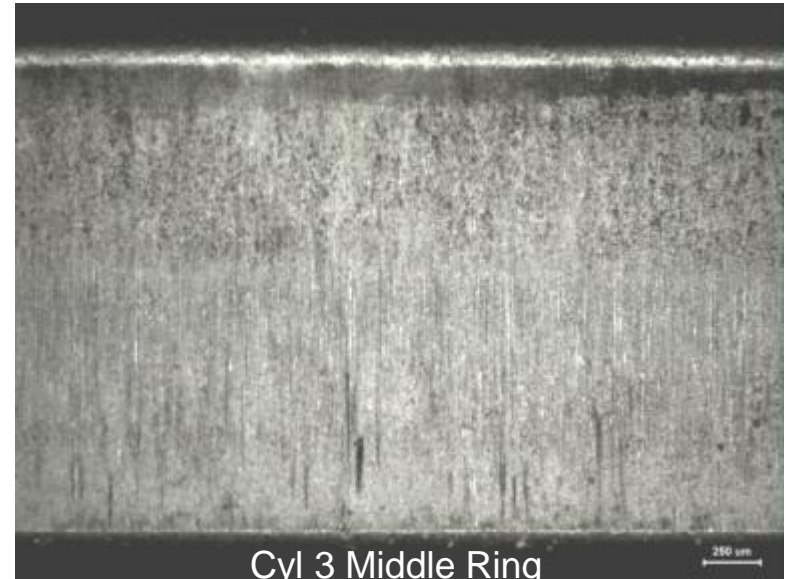
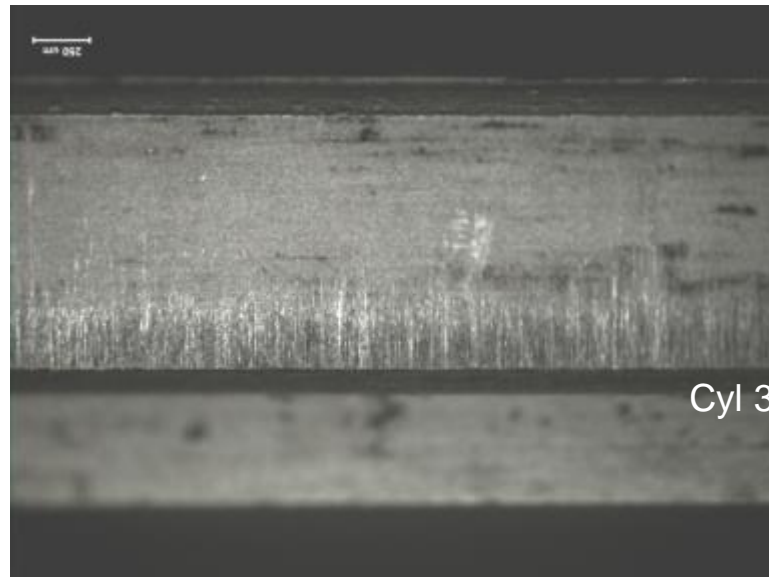
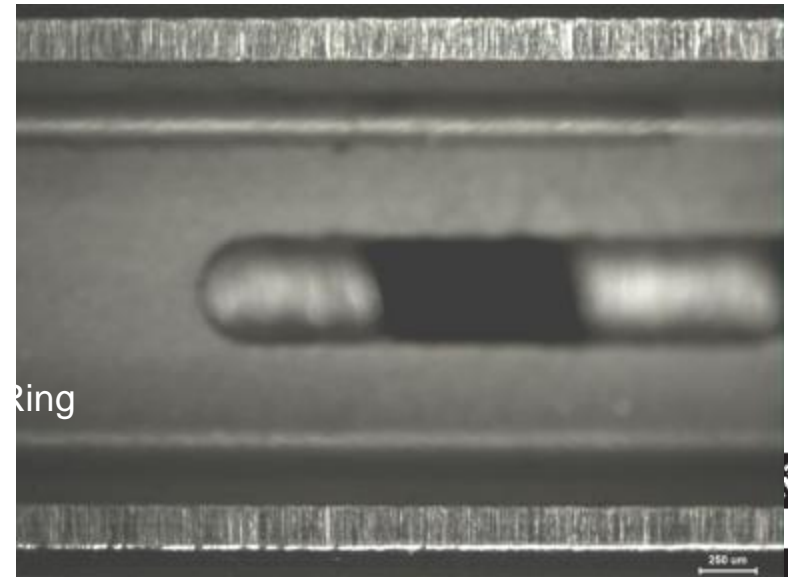
Rusted Cylinder Bores

- These photos show the extreme wear to the rings caused by the rust in the cylinder bores.

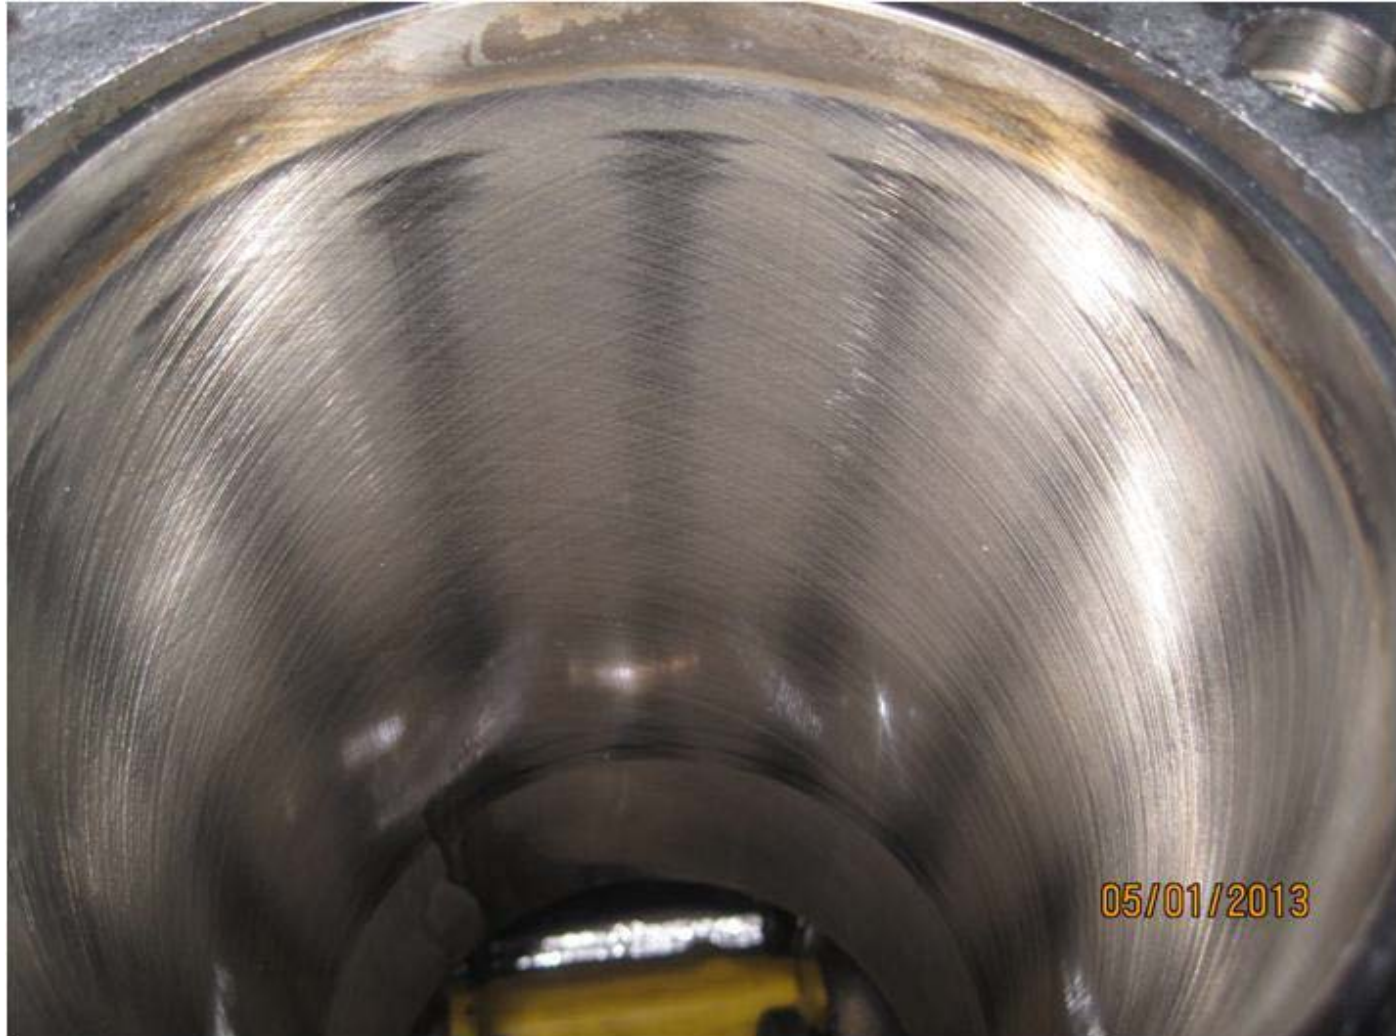
- Liner has a 13 vertical lobe pattern that the piston rings do not conform to. This allows unscraped oil to pass into the combustion chamber and be consumed. This condition will also accelerate piston carbon packing.

Correlation to carbon packing is still under investigation

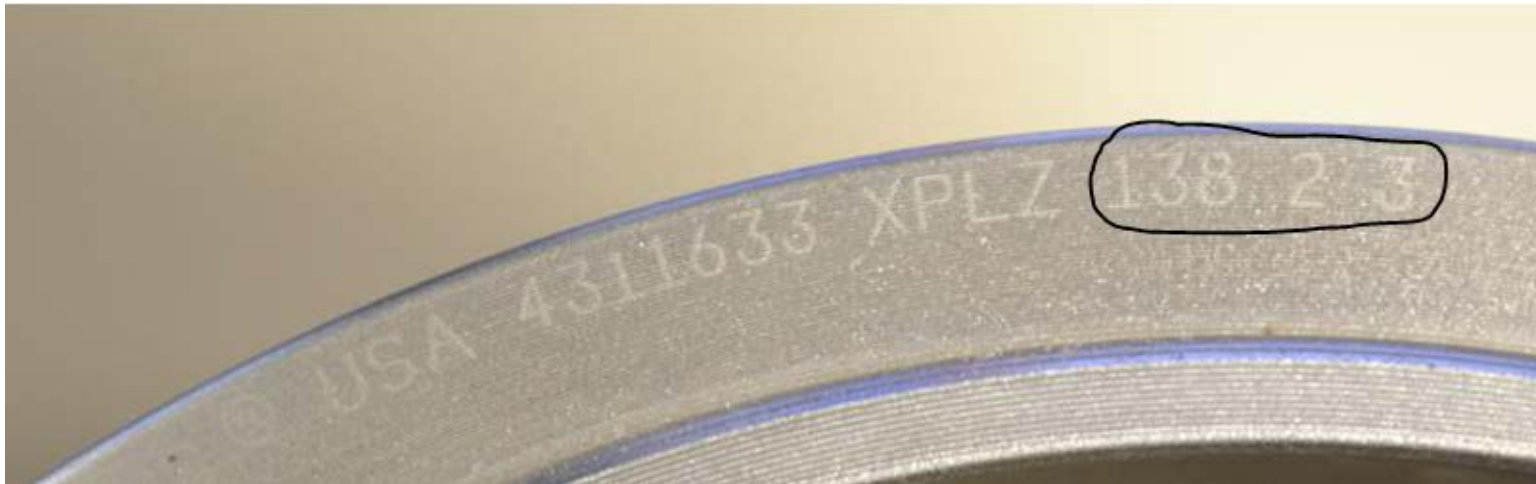
Liner Identification Date Codes

- GKN USA Liner
- –Date code located on the liner combustion seal seat
- •**138 2 3** = Day 138 - 2012 – 3rd shift = May 18th 2012 3rd shift
 - Date codes are difficult if not impossible to see on a used liner. This reference is for new liners.
