Fault Code 51 - Rail Position Sensor

J1587: MID 130 SID 60 FMI 2, 3, 4, 10
J1939: SA 3 SPN 60 FMI 2, 3, 4, 10

Overview

This fault code indicates an electrical failure of the Rail Select Sensor or mechanical failure on the Electric Shifter.

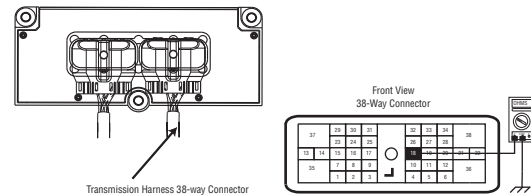
Purpose: Test the Rail Position Sensor Plus line for shorts to ground through the Transmission Harness.

1. Measure resistance between Transmission Harness 38-way connector Pin 18 to ground.

- If resistance is OL, Reconnect 38-way connector, (if fault code is Active) replace the:
 - **Medium-Duty Transmission Electronic Control Unit (TECU)**
 - **Heavy-Duty Transmission Electronic Control Unit (TECU)**
- If FMI 2, 3, 4, or 10 is present with an Inactive code, replace the **Electric Shifter** and the:
 - **Medium-Duty Transmission Harness**
 - **Heavy-Duty Transmission Harness**
- If resistance is less than 10K ohm, go to **Step C.**

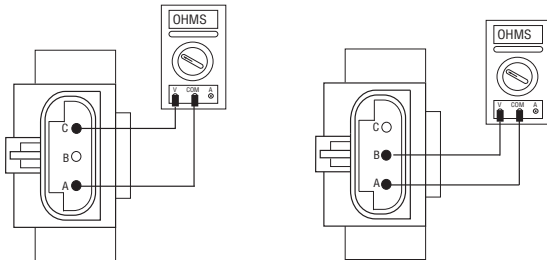
Purpose: Measure resistance of the Rail Position Sensor.

1. Disconnect Transmission Harness from Rail Select Sensor.
2. Measure resistance between Pin A and Pin C and between Pin A and Pin B on the Rail Select Sensor.

- If resistance between Pin A and Pin C is 5K to 7K and between Pin A and Pin B is 100 to 200 ohms, go to **Step D**.
- If any of the above conditions are not met, replace the **Electric Shifter**. Go to **Step V**.
