## Fault Code 73: Failed to Engage Gear

**J1587: MID 130**    **SID 58**            **FMI 7**  
**J1939: SA 3**        **SPN 781**           **FMI 7**

### Overview

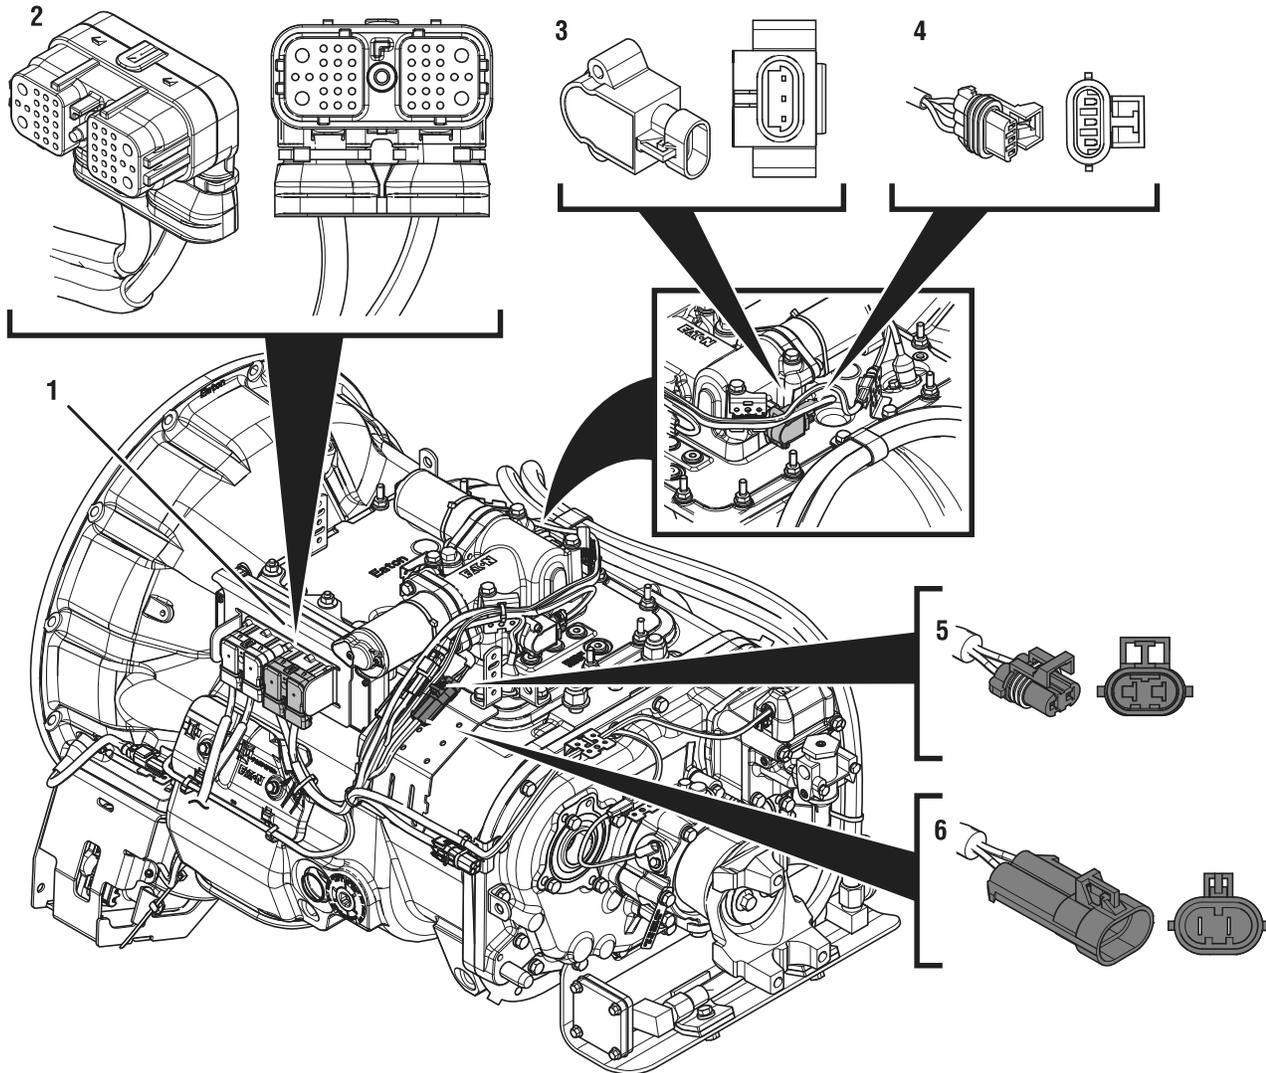
1. Transmission Electronic Control Unit (TECU)
2. 38-Way Transmission Harness Connector
3. Gear Position Sensor
4. 3-Way Gear Position Sensor Connector
5. 2-Way Gear Motor Connector (blue)
6. 2-Way Gear Motor Connector Body (blue)

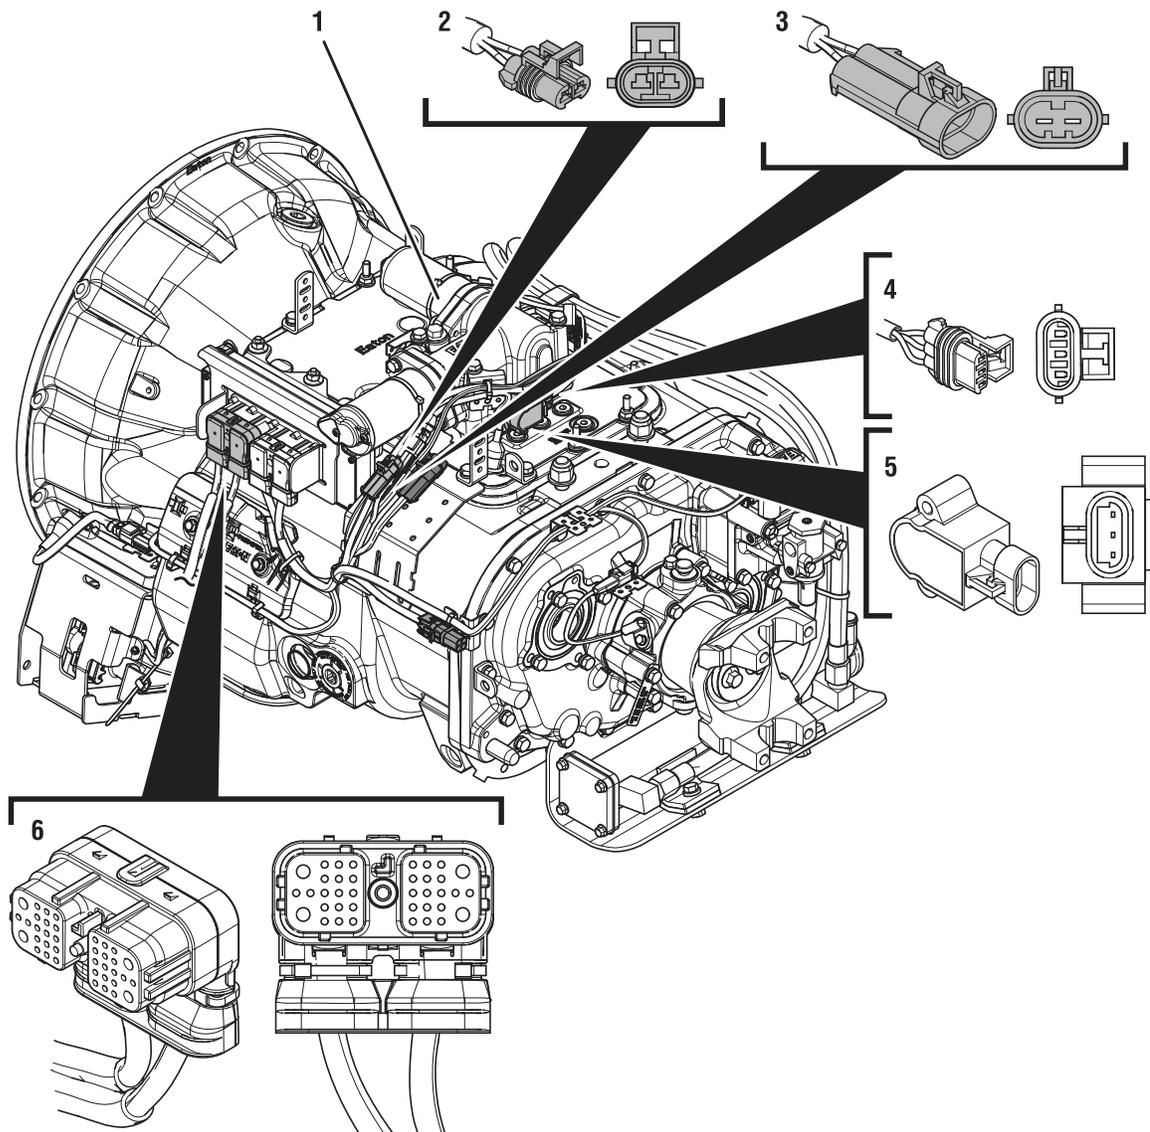
1. X-Y Shifter
2. 2-Way Rail Motor Connector (black)
3. 2-Way Rail Motor Connector Body (black)
4. 3-Way Rail Position Sensor Connector
5. Rail Position Sensor
6. 38-Way Vehicle Harness Connector

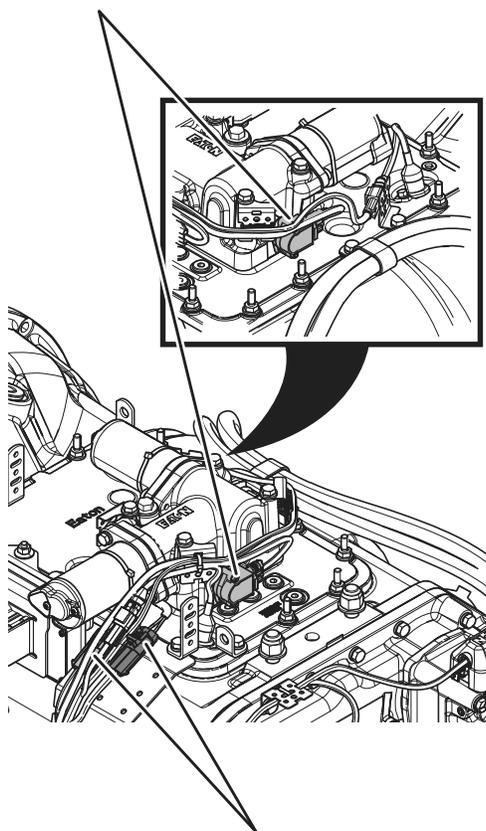
2. Inspect the physical condition of X-Y Shifter and all connections.
3. Inspect Transmission Harness for any pinched, chafed, corroded or shorted wiring.
4. Disconnect both 2-Way X-Y Gear and Rail Position Sensor Connectors.

5. Disconnect both 2-Way X-Y Motor Connectors to the Transmission Harness.
6. Inspect connectors for corrosion, loose terminals, bent or spread pin or damage to the connector bodies.
  - If damage to the X-Y Shifter or X-Y Shifter wiring is found, replace **X-Y Shifter**. Go to **Step V**.
  - If damage to the Transmission Harness is found, replace **Transmission Harness**. Go to **Step V**.
  - If no damage is found, go to **Step G**.

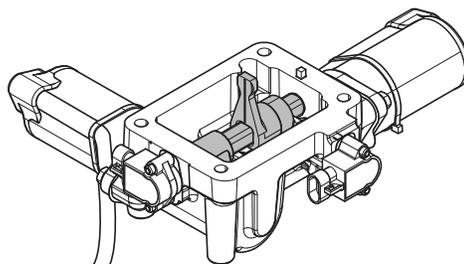
1. Key off.
2. Remove the X-Y Shifter.
3. Inspect condition of the X-Y Shift Finger and Cross Shaft for damage or wear.

4. Inspect the X-Y Shifter ball screw for signs of coolant contamination.

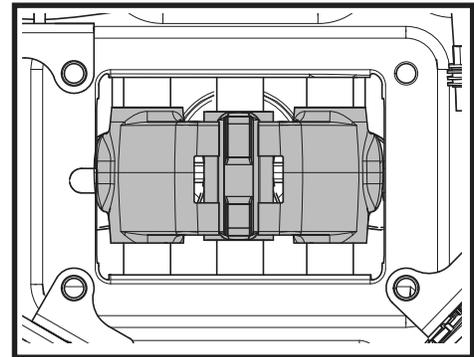
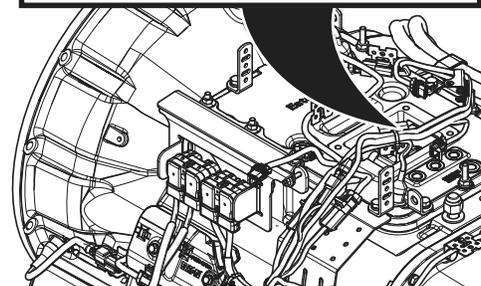
1. Key off.
2. Inspect condition of the Shift Bar Housing Shift Blocks. Look for uneven gaps between the Shift Blocks or excessive wear to the block faces.
3. Verify Shift Blocks are tight to the rails and there are no other mechanical issues with the Shift Bar Housing.
